# Moorepark Dairy Levy Research Update

## Teagasc Heavy Soils Programme – Lessons Learned

*A guide to the key findings of the Teagasc Heavy Soils Programme to-date*

May 2021

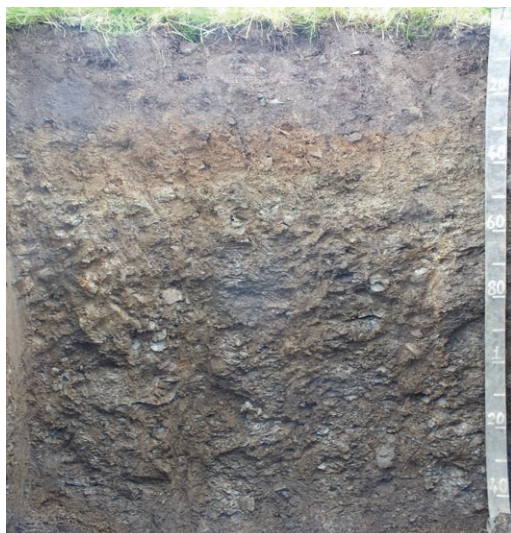
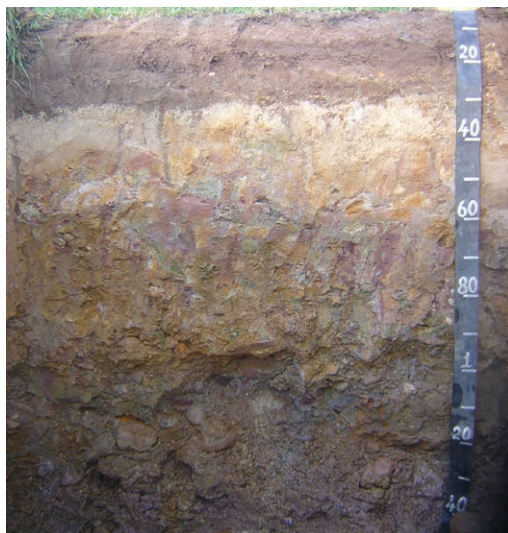
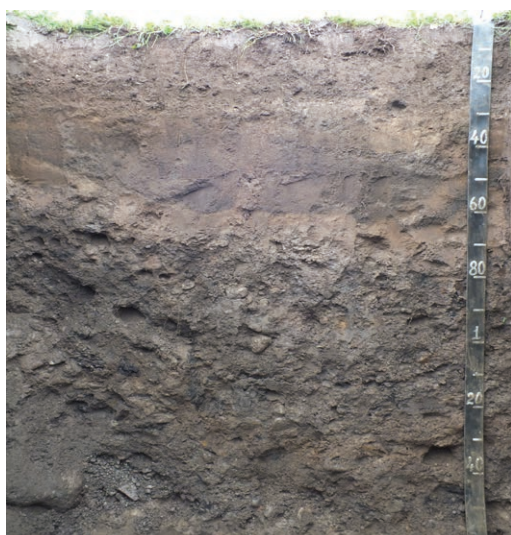
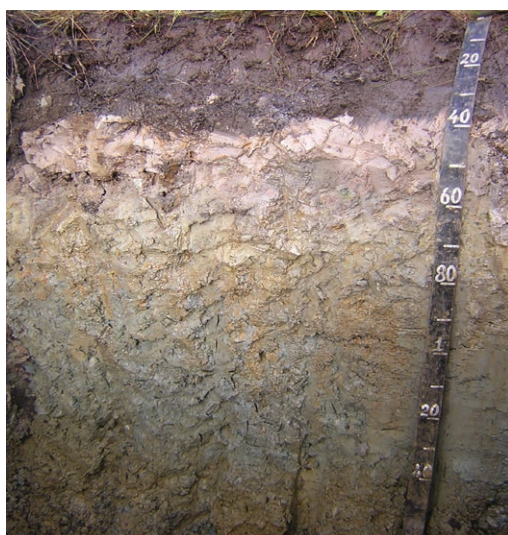
Stagnic Brown Earth: 14.0Ha in Stradone

Surface Water Gley: 12.4Ha in Rossmore

Gleyic Brown Earth: 12.4Ha in Crossmolina

Humic Alluvial Gley: 5.3 Ha in Kishkeam

**Figure 7.** Example soil profiles from four HSP farms and their extent at each location.

The natural variability of soils is apparent between different regions of the country, and indeed within farm boundaries. A campaign to classify, sample, measure and map soil type and characteristics at a paddock scale across the programme farms was undertaken as part of the Heavy Soils Programme. In order for the Programme to develop coherent and credible management techniques and strategies for all soil types and variations thereof, in-depth knowledge of the individual soils was required. The capture of high resolution and spatially explicit soil data enables an understanding of the agronomic and environmental aspects that need to be considered in the development of each farm. The deliverables from this exercise included: high resolution soil maps, detailed soil classifications, measurement and interpretation of soil hydrological and chemical characteristics and a bank of soil samples from each farm. The soil type, soil series and drainage class of the dominant soil in each paddock was outlined. Some example soil profiles are shown in Figure 7.

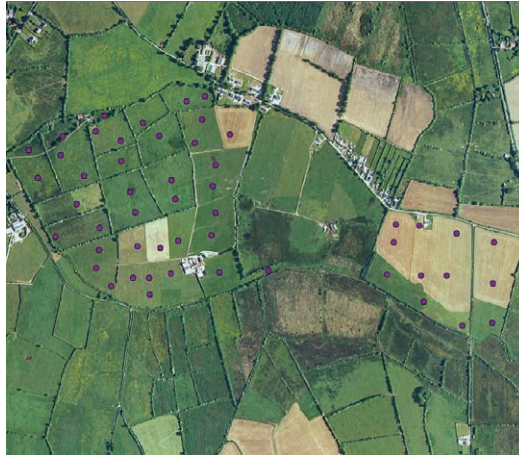
**Figure 8.** Extent of auger survey at Castleisland, Co. Kerry

Mapping of the location and extent of each soil type on a given farm was established through an auger and test pit survey. Initially an auger survey was carried out on each farm, involving an auger bore on average every hectare to investigate the soil physical features. Their resulting distribution was an even coverage across each farm (Figure 8). The Dutch auger was driven into the soil to a depth of 1 m. The soil features were described and recorded. Horizon type, depth, texture, colour, mottling, structure, roots and stones were recorded along with many more physical attributes detailed in the Irish Soil information system soil profile handbook. Soil type and drainage class were assigned.

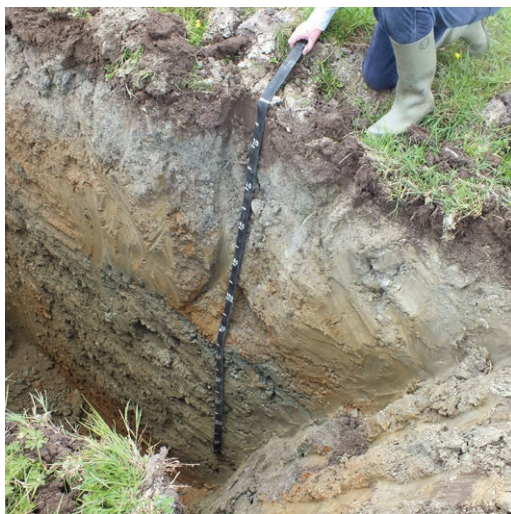
**Figure 10.** Test pit excavation

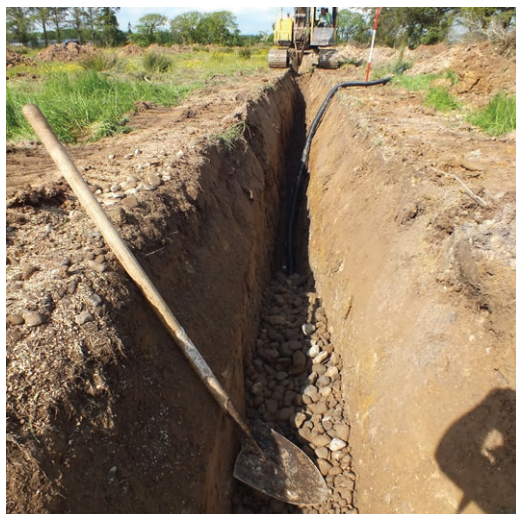
**Figure 11.** Drainage trench excavation

Clean aggregate, in the 10 – 40 mm grading band, should be used to surround the drain pipe. The gravel should be filled to a minimum depth of 300 mm from the bottom of the drain to cover the pipe. The stone should provide connectivity to a layer of high permeability and should not be filled to the ground surface. The purpose of a drain pipe is to facilitate a path of least resistance for water flow. In long drain lengths (greater than 30m) a drain pipe is vital to allow a high a flow-rate as possible from the drain, stone backfill alone is unlikely to have sufficient flow capacity to cater for the water volume collected.

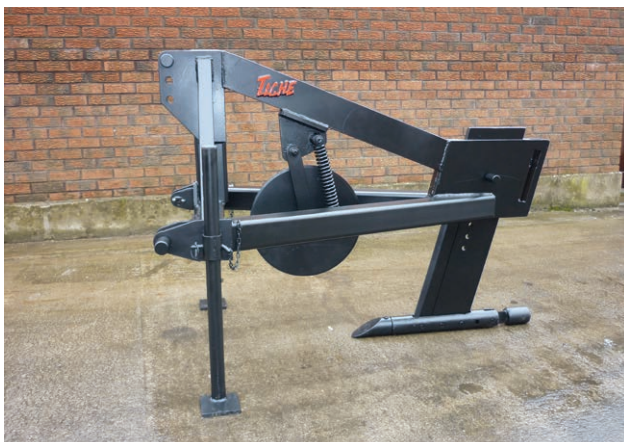
**Figure 12.** Mole plough showing cylindrical foot and expander

Mole drainage is suited to stone-free soils with a high clay content which form stable channels. Mole drains are formed with a mole plough comprised of a torpedo-like cylindrical foot attached to a narrow leg, followed by a slightly larger diameter cylindrical expander. The foot and trailing expander form the mole channel while the leg creates a narrow slot that extends from the soil surface to the mole channel depth. The mole plough creates both a zone of increased permeability adjacent to the mole leg (shallower depths) and a channel for water flow at moling depth. The effectiveness of mole drainage will depend on the extent soil cracking during installation. As such the ideal time for carrying out mole drainage is during dry summer conditions, to allow for maximum cracking in the upper soil layers and adequate traction to prevent wheel-spin on the surface.

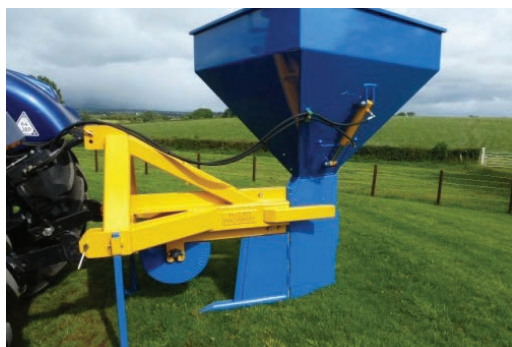
**Figure 13.**Gravel mole plough showing hopper

Gravel filled moles employ the same principles as ordinary mole drains but are required in soils which will not sustain an unlined channel. The gravel mole channel is filled with gravel from an attached hopper which supports the channel walls. Gravel moles require a very specific size range of gravel aggregate to ensure that they function properly. Washed aggregate within a 10-20 mm size range should be used. Sub-soiling is used effectively where an iron pan or cemented layer impedes drainage. The effect is to break the layer and crack the soil. A stable channel will not be formed.

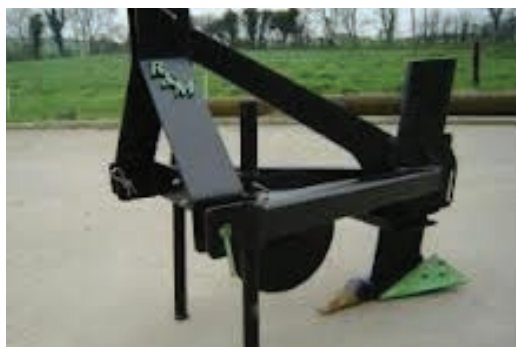
**Figure 14.**Single leg winged sub-soiler

Sub-soiling was carried out with a single leg winged sub-soiler (below) to improve permeability of the upper layers and increase the level of infiltration of surface water into the soil profile and ultimately into the collector drains. Sub-soiling was carried out at a depth of 0.6 m and a spacing of 1.5 m when good weather ensured dry soil conditions and allowed for the maximum level of soil disturbance. The depth of sub-soiling was set to ensure maximum fracturing and disturbance of the soil. The spacing was determined as the closest spacing allowable given the width of the tractor used for drawing the sub-soiler and the need to avoid tracking over the newly formed disruption channels.

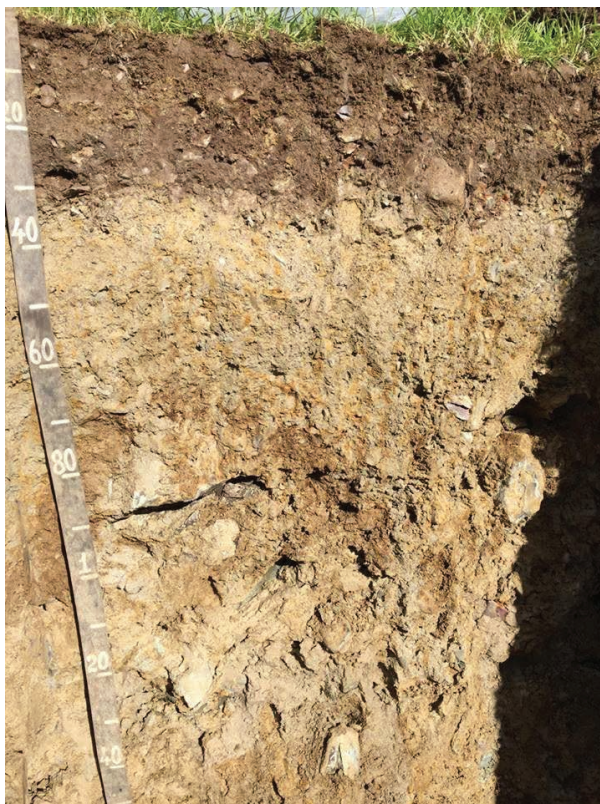
**Figure 15.** Typical soil profile at Ballinagree, Cork site

As a first step soil test pits were dug to examine the soil profile. The profile uncovered (pictured below) contained evidence of slow water infiltration (drainage) and movement. Strong seepage of groundwater into the pit was noted from approximately 1.5 m depth. Given the position of the site in the landscape (mid-slope on steep high ground) it was concluded that groundwater, moving downslope, was maintaining a shallow watertable and inhibiting surface water infiltration. Drainage on this site would have to remove this excess water to control the watertable depth and allow increased surface water infiltration. The design required is classed as a groundwater drainage system, comprising field drains located in the layer where groundwater can move (from approx. 1.5 m depth in this case). Soil test pits also uncovered a number of large stones and boulders (0.1 – 0.8 m approximately in size). Such stones would make excavation of field drains and removal of soil more problematical.

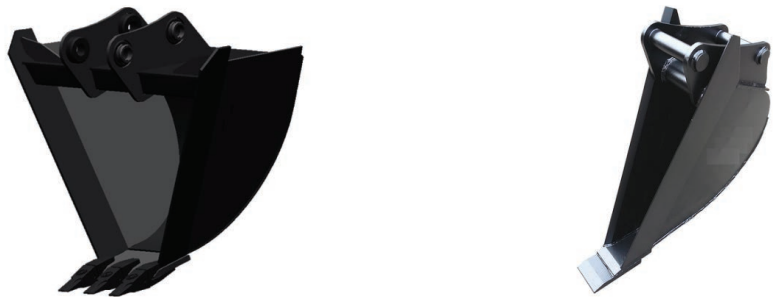
**Figure 18.** (a) Trapezoidal moulding bucket and (b) narrow drainage bucket

It was decided to install groundwater drains to a minimum depth of 1.7 m and a 20 m spacing (see map) spanning the width of the site and running across the main field gradient. The existing open drain at the eastern side of the site was cleaned and deepened to a depth of 2 m to act as an outfall for the new field drains. The existing gullet at the field outlet point was lowered to allow for this. The existing open drain at the northern end of the site was also deepened to 1.7 m, to intercept as much groundwater and surface water (coming from the adjacent forestry) as possible before it could enter the site. Field drains were installed in two stages in order to avoid difficulties related to subsidence and collapse of the field drain trench during installation. Initially a 1.0 m deep trench was excavated using a wide moulding bucket, after this a narrower tile drainage excavator bucket (pictured below) was used to complete the drain to its final depth (1.7 m). Each drain was installed and backfilled immediately. The groundwater drains consisted of an 80 mm corrugated perforated PVC pipe with a gravel aggregate envelope (10 - 40 mm grade) backfilled to within 1.3 m of the soil surface (to ensure maximum connection to the high permeability soil layer) and thereafter backfilled with soil (and larger stones/boulders raised during drain excavation).

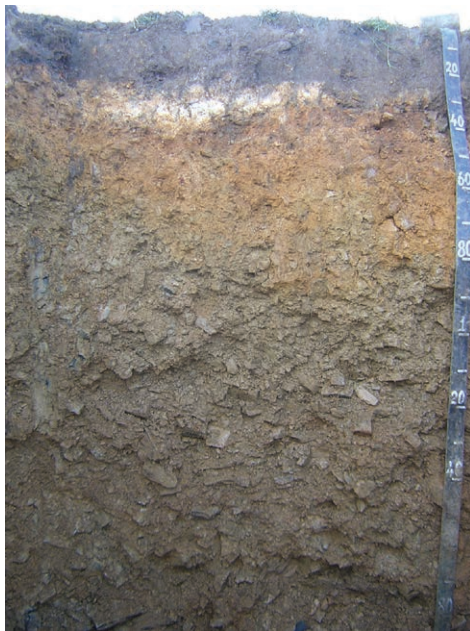
Figure 19. Typical soil profile at Kishkeam, Cork site

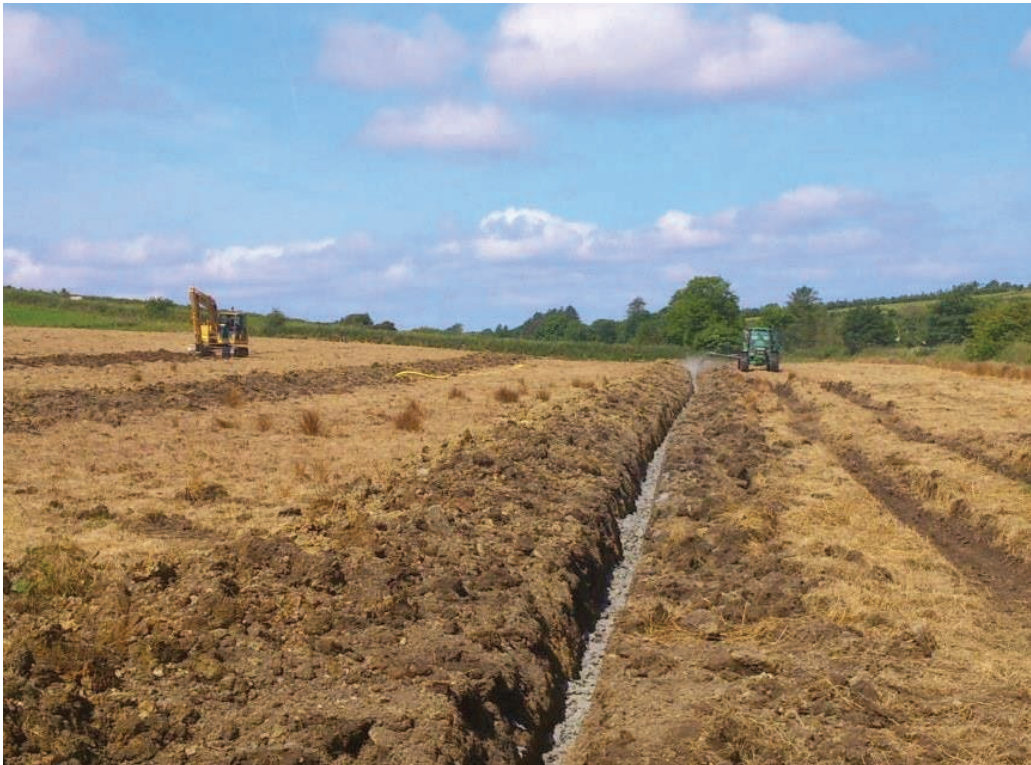
**Figure 22.** Drainage Work at Kishkeam, Co. Cork

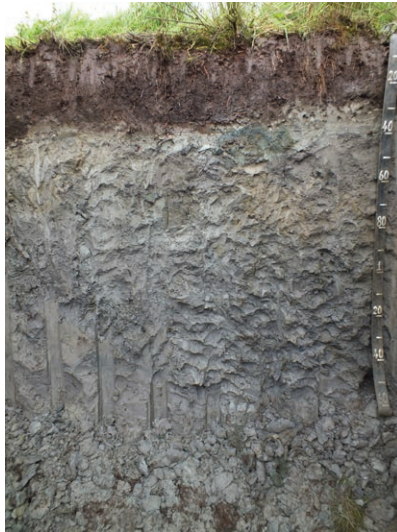
**Figure 23.** Typical soil profile at Crossmolina, Co. Mayo site

As a first step soil test pits were dug to examine the soil profile. The profile uncovered (pictured below) contained evidence of slow water infiltration (drainage) and movement. A thin topsoil was underlain by a uniform silt with some mottling (discolouration) becoming more permeable from 1.4 m depth. Strong seepage of groundwater into the pit was noted from approximately 1.4 m depth consistently across the site. The most appropriate drainage system for this site would be a groundwater drainage system which would remove excess groundwater and allow surface water to infiltrate through the profile. In this case the drains would be located in the layer where groundwater can move, at approximately 1.4 to 1.7 m.

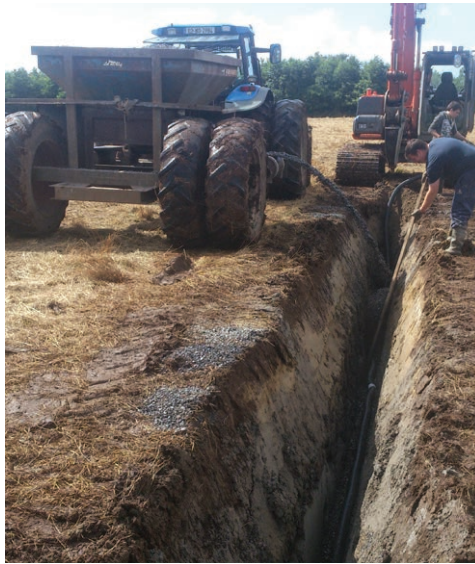
**Figure 26.** Drainage work at Crossmolina, Co. Mayo

It was decided to install groundwater drains to a minimum depth of 1.7 m (see map) spanning the width of the site and running across the main field gradient. The placement of the drains did not follow any set pattern and was dictated by the field topography. Drains were positioned in natural depressions and along slope contours to ensure the natural flow of water was encouraged into drains. The existing open drain at the southern side of the site was cleaned and deepened to a depth of 2.0 m to act as an outfall for the new field drains. The existing culvert at the field outlet point was lowered to allow for this. This culvert was under a public road which had to be cut during the works and re-laid thereafter. Providing an outlet from the field was a major undertaking, an additional 250 m of open drain had to be excavated and the works required in the digging of this and removal of associated spoil added significantly to the overall cost. The existing open drain at the northern end of the site was also deepened to 1.8 m, to intercept as much water (coming from the adjacent areas) as possible before it could enter the site. Drains were installed in two stages in order to avoid difficulties related to subsidence and collapse of the field drain trench during installation. Initially a 1.0 m deep trench was excavated using a wide moulding bucket, after this a narrower tile drainage excavator bucket (as described earlier) was used to complete the drain to its final depth (1.7 m). Each drain was installed and backfilled immediately. Even using this strategy there was particular sections which collapsed and slowed the progress of installation. The groundwater drains consisted of an 80 mm corrugated perforated PVC pipe with a gravel aggregate envelope (10 - 40 mm grade) backfilled to within 1.2 m of the soil surface (to ensure maximum connection to the high permeability soil layer) and thereafter backfilled with soil.
