Alan Wood, Co. Mayo

Alan Wood – Drainage Costs

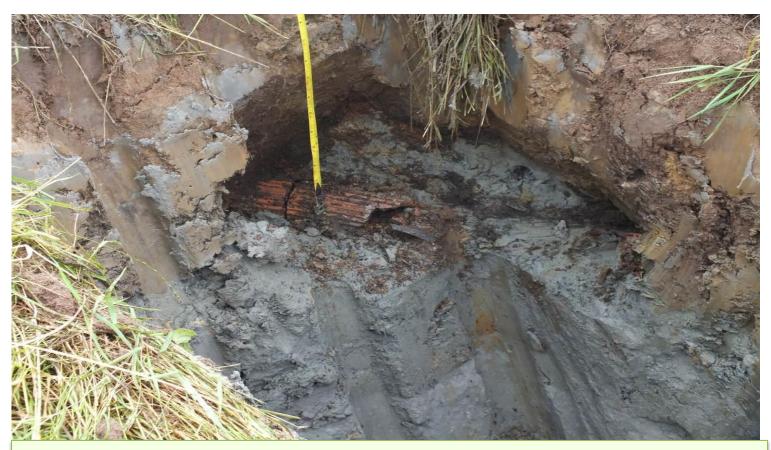
Old clay drain that was laid at 60 cm in the late 1950's as part a land drainage scheme. These drains worked for 20 years. They eventually got blocked up and the field performance went into decline culminating with very heavy poaching in 2012 and poor grass production.

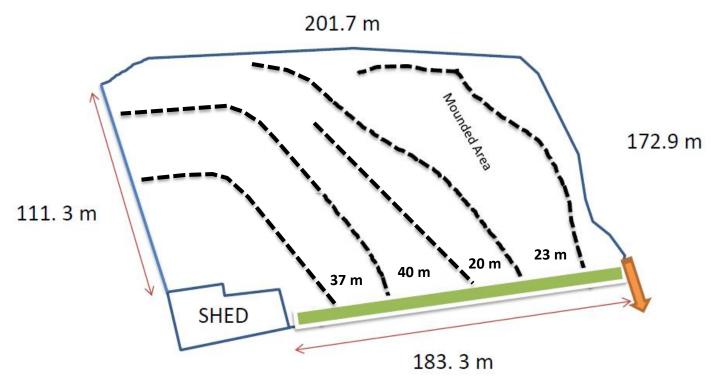
5 Groundwater drains, 1.7 m deep

Outlet runs under public road and transferred to lake

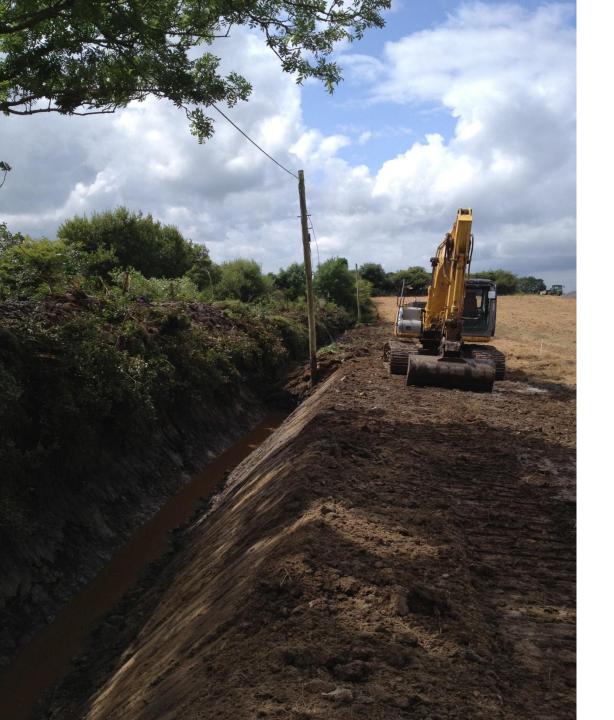
Open Drains:

- Deepened
- Widened

Towards Lake Conn

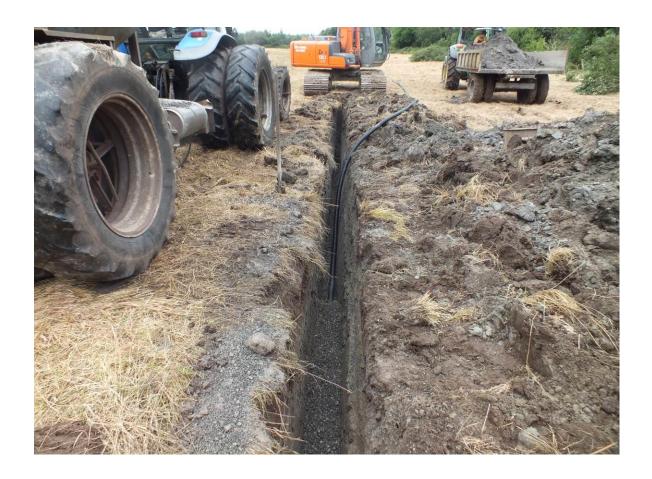
Installation of drains at 1.7 m deep. 80mm drainage pipe was used with 60cm of 10 - 40 mm clean stone. Some spoil was removed as drains were being dug.
