Teagasc Water Quality Conference 2026

National Agricultural Inspection Programme (NAIP)

What issues are being identified on farms

Frank O'Flynn,
Senior Executive Scientist
Cork County Council

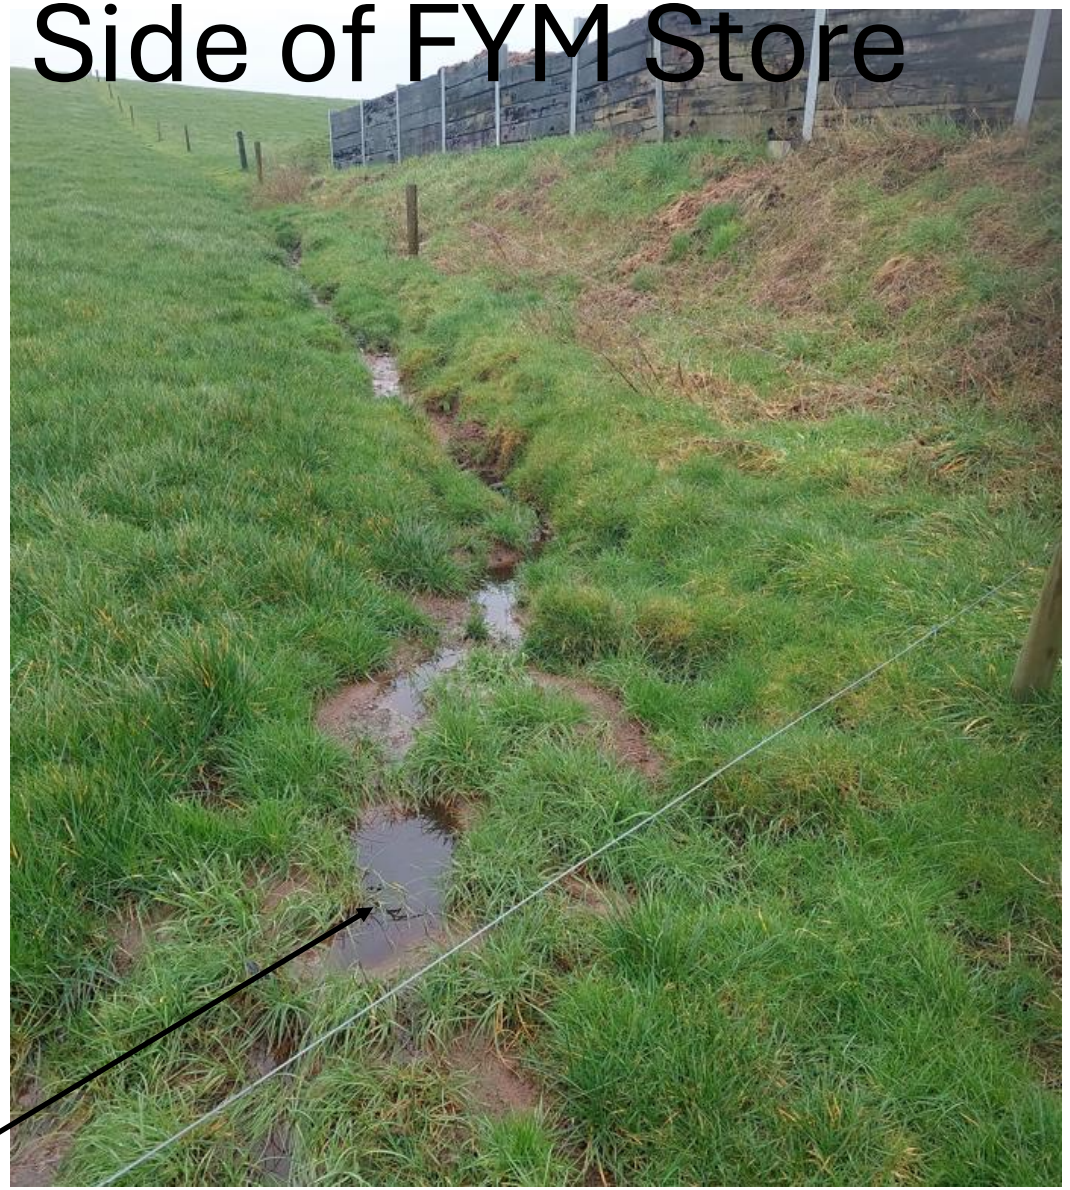
Polluting runoff from FYM

Drainage from FYM Store and Open Yard

Slatted tank Overflowing

Flow of Effluent Downslope of Slatted tank

Effluent Discharge

Effluent Flow on Road

Discharge to Watercourse

Silage Bales, No Effluent Control

Soiled Water/Effluent discharge to roadside

- Large open feed passages generating large volumes of soiled water.
- Large areas of yards with no differentiation between clean and dirty yards.
- Inadequate slurry/soiled water storage capacity, tanks overflowing.
- Poorly constructed and managed FYM Store.
- Silage bales 3 high with no effluent collection.
- Direct discharges to waters.

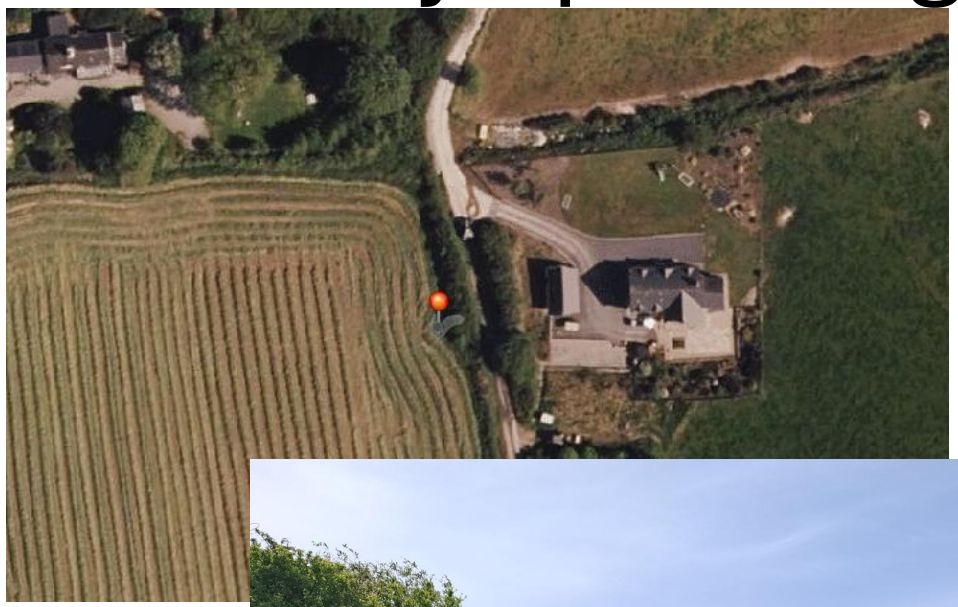
Slurry Spreading Buffer Zones June 2026

- Slurry spread within 5m of private water well
- This had happened again 5 months before and well was polluted.
