Teagasc Heavy Soils Dairy Programme Review

Complied by

Objectives of Heavy Soils Programme

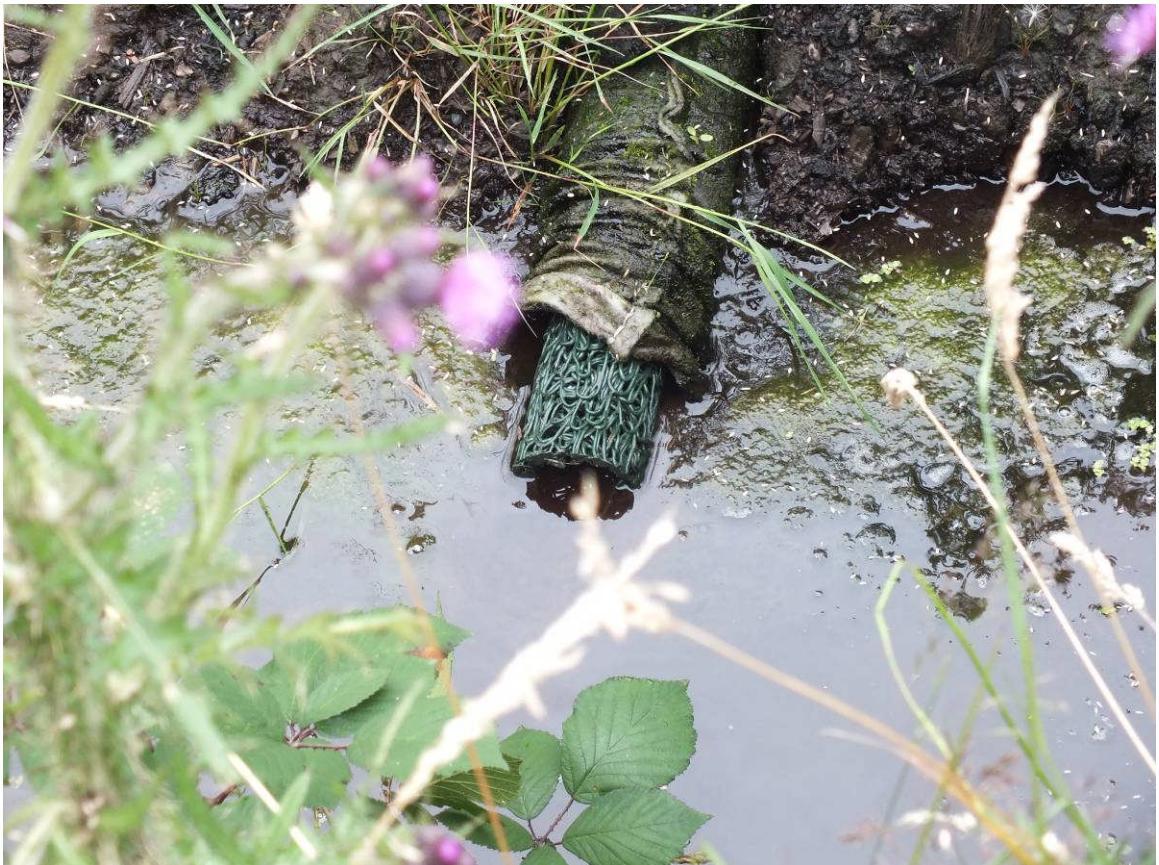
Picture 2: Connacht Agri pipe with filter around it

More recently Danny has used the Connacht Agri piping see Picture 2. This cost ≤ 4.50 / metre (≤ 3.50 per metre to buy pipes and ≤ 1 /metre for digger and labour to install). It has worked well in swampy peat as there is no stone used which means that the use and cost of a tractor and stone cart are avoided.

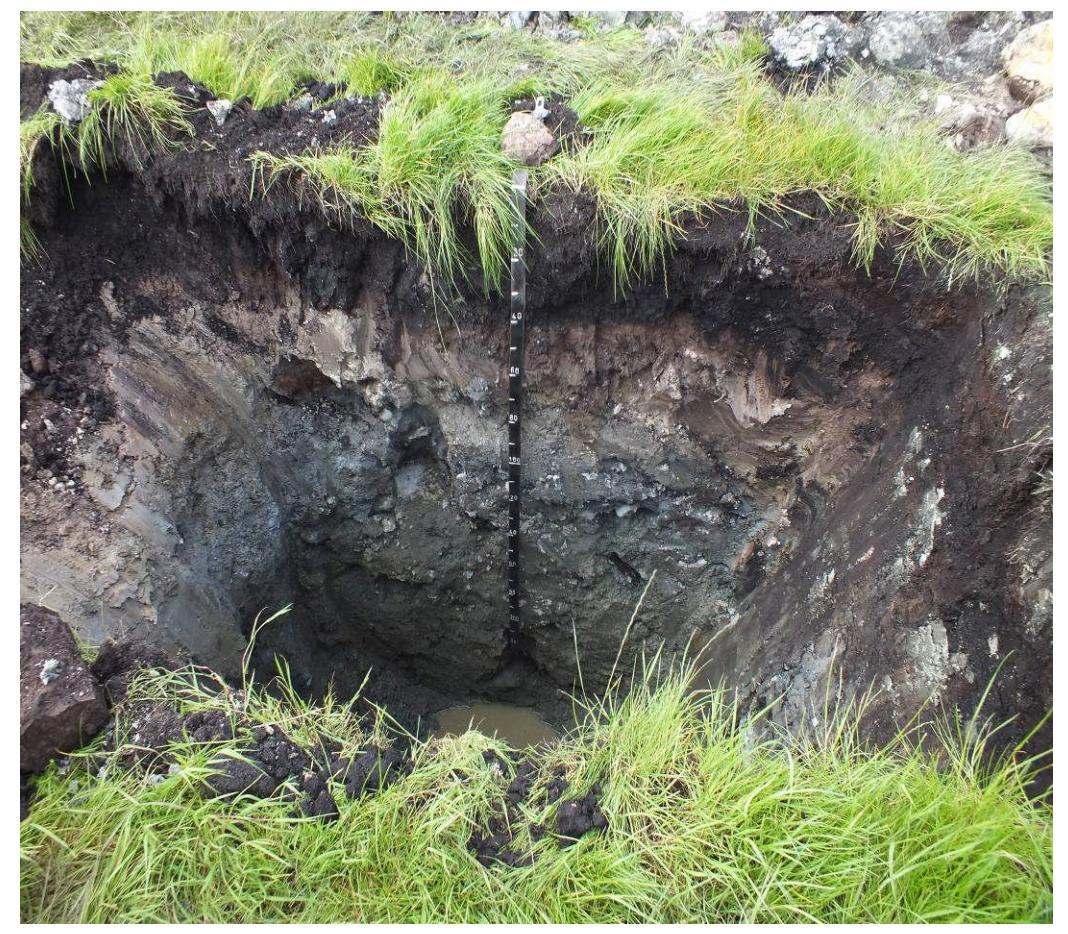
Test hole 1 near Cree River

Depth cm	Description
0 - 40	Peat
40 - 70	White silty clay with a stone layer, quite bouldery
70 - 125	Less stony, poorly structured, very dense glacial till, upper carboniferous
125 - 240	Slightly looser and better structured sandstone influence, fissured shale, substantial ingress of water

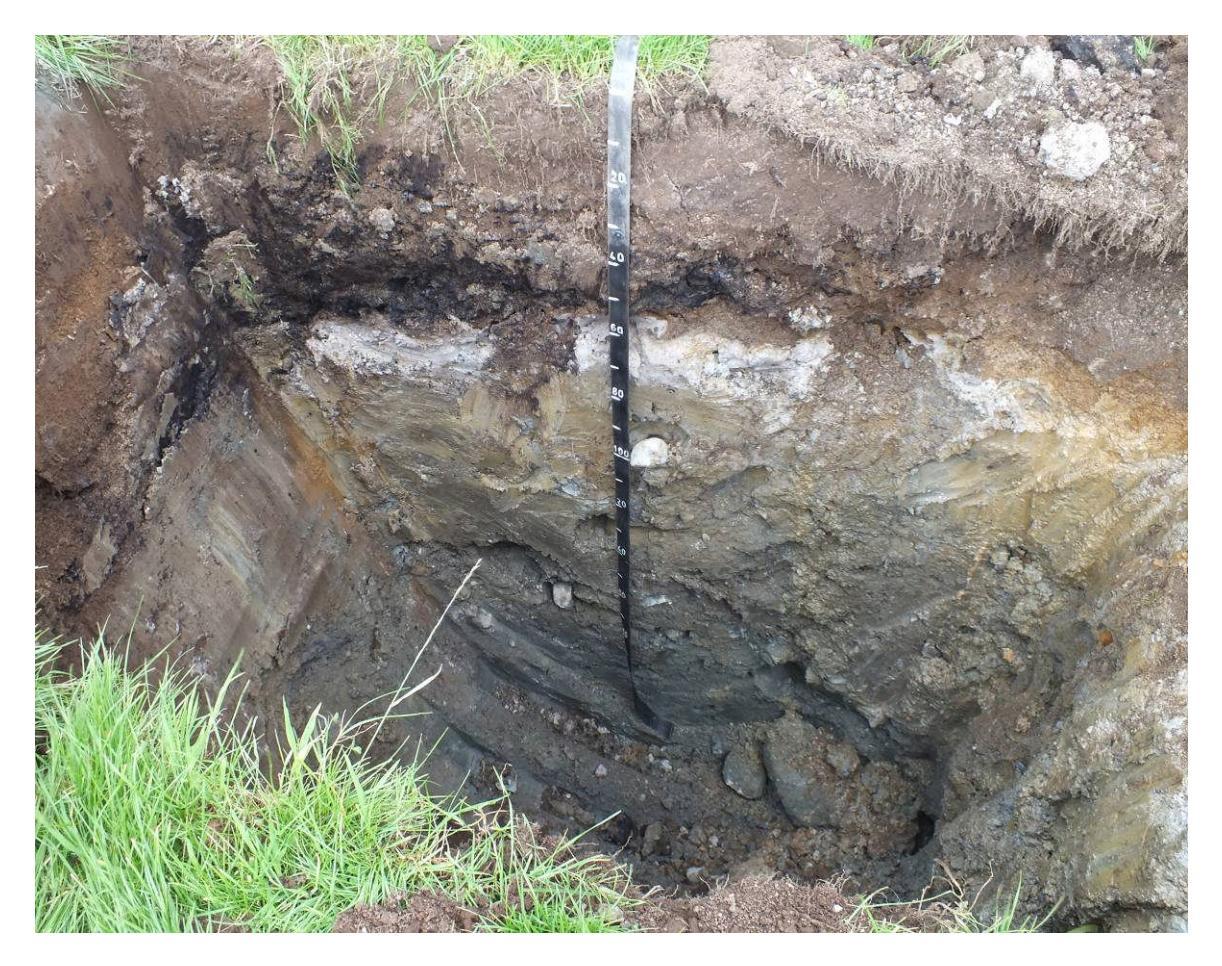
Test Hole 2 near Cree River

Depth cm	Description
0 - 40	Peat
40 - 70	White silty clay
70 - 125	Poorly structured, very dense Glacial till, Upper carboniferous
125 -300	Slightly looser and better structured sandstone influence

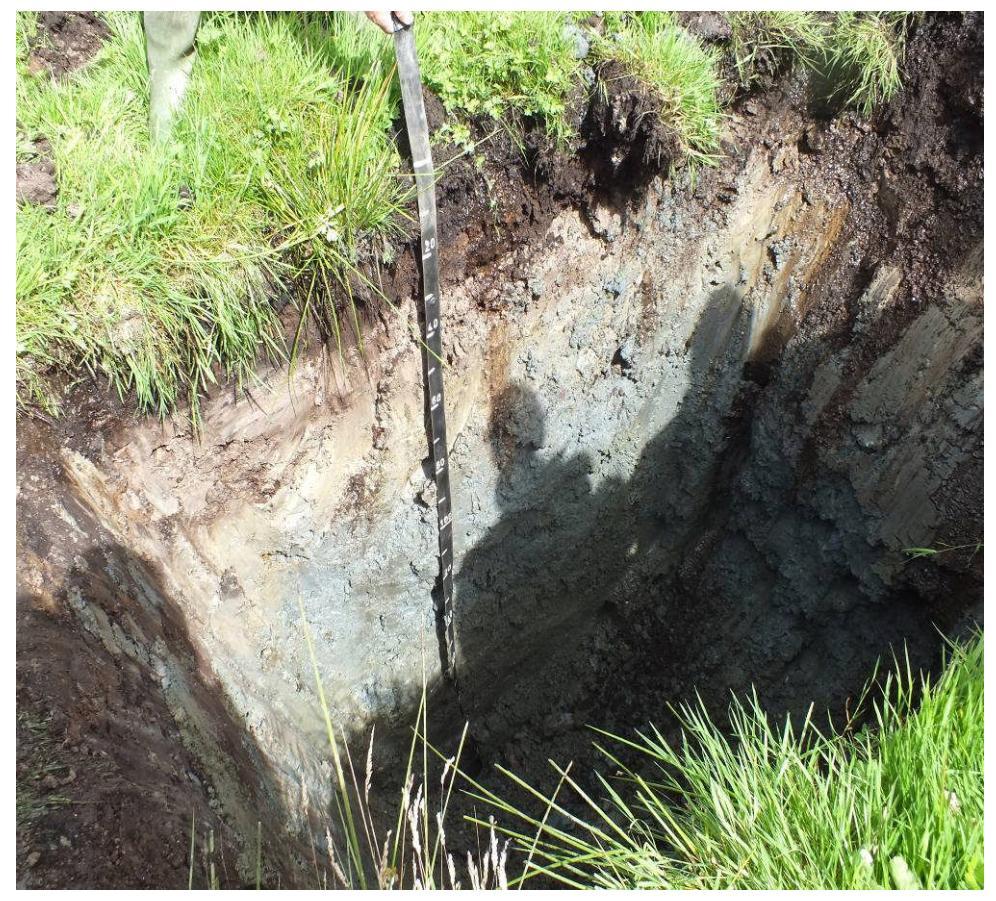
Test hole 3 near Doonbeg River

Depth cm	Description
0 - 30	Cut away peat
30- 70	White silty clay
80-240	Poorly structured, very dense Glacial till, Upper carboniferous

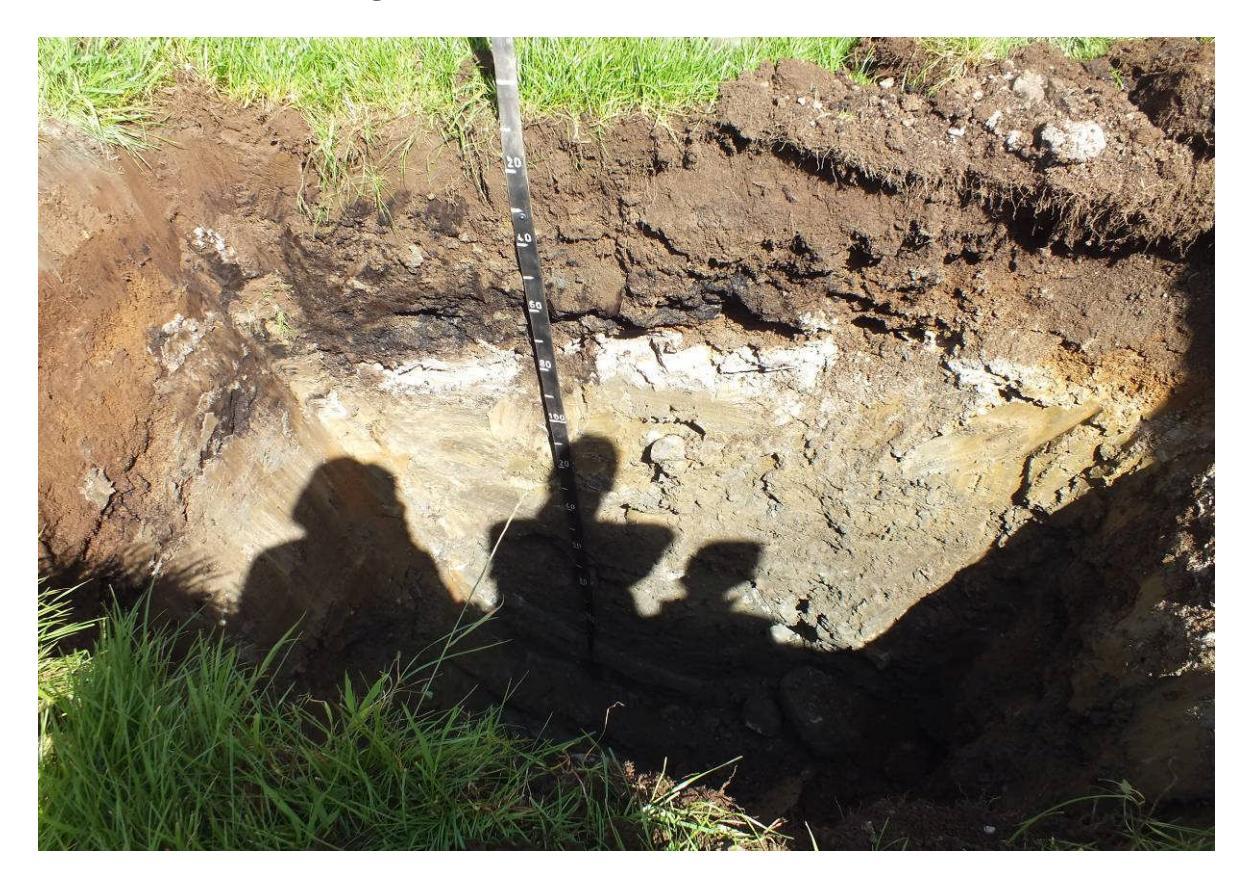
Test hole 4 near Doonbeg River - dry piece of ground with wet areas all around

Depth cm	Description
0 - 40	Moderate organic top soil, silty loam
40- 70 (varying 0 -30)	Manganese concretions resulting from varying water table
70 - 90	White silty clay
80 – 210	Poorly structured very dense Glacial till Upper carboniferous

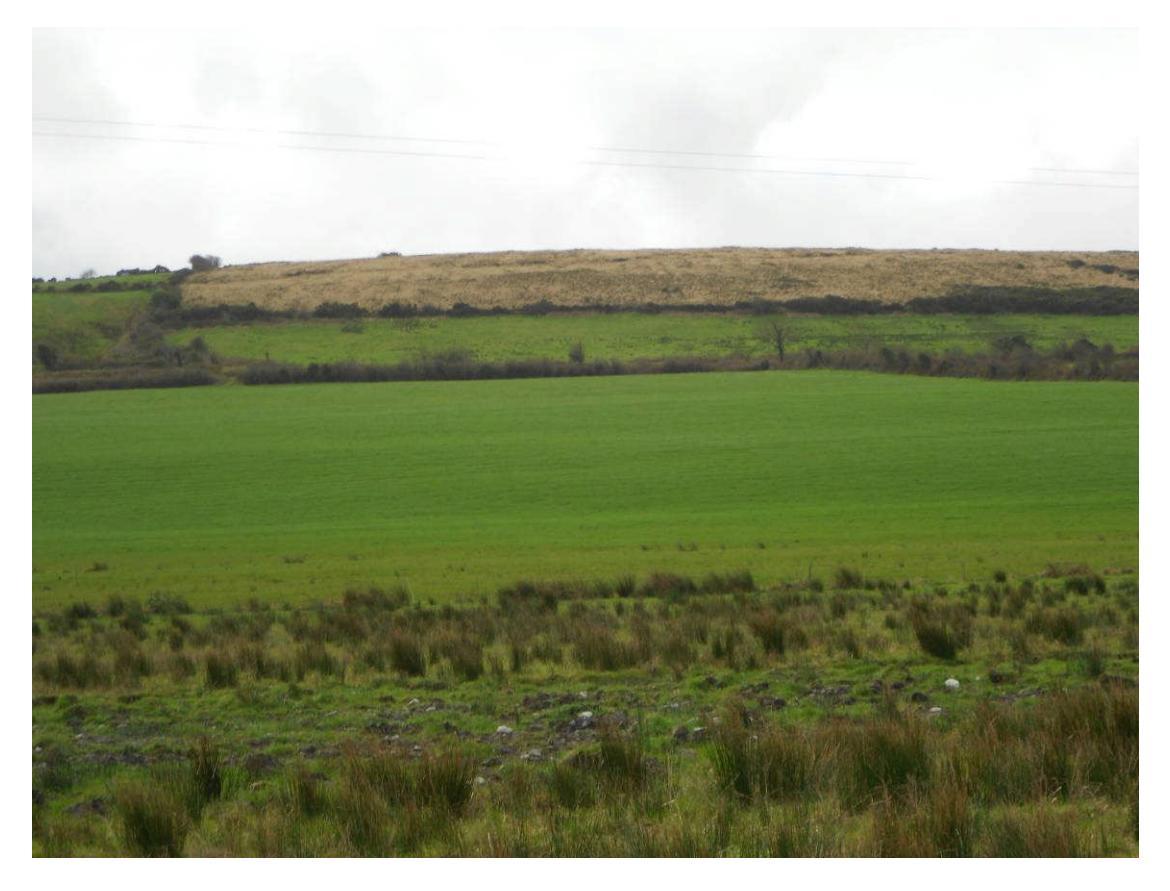
Picture 1

Notes on picture 1. All on carboniferous shale. Blanket peat on top of hill. Side of hill (green grass) soil surface is shallower, rock underneath more fissured shale on top giving good drainage as water is moving down, spring rising in field confirming assumptions.

Base of hill area that was turned last year.

At bottom of the field soil depth begins to increase and get wetter. Rock may have been protected during ice age and as a result not as broken but in any event the depth of soil would lead to poor drainage.

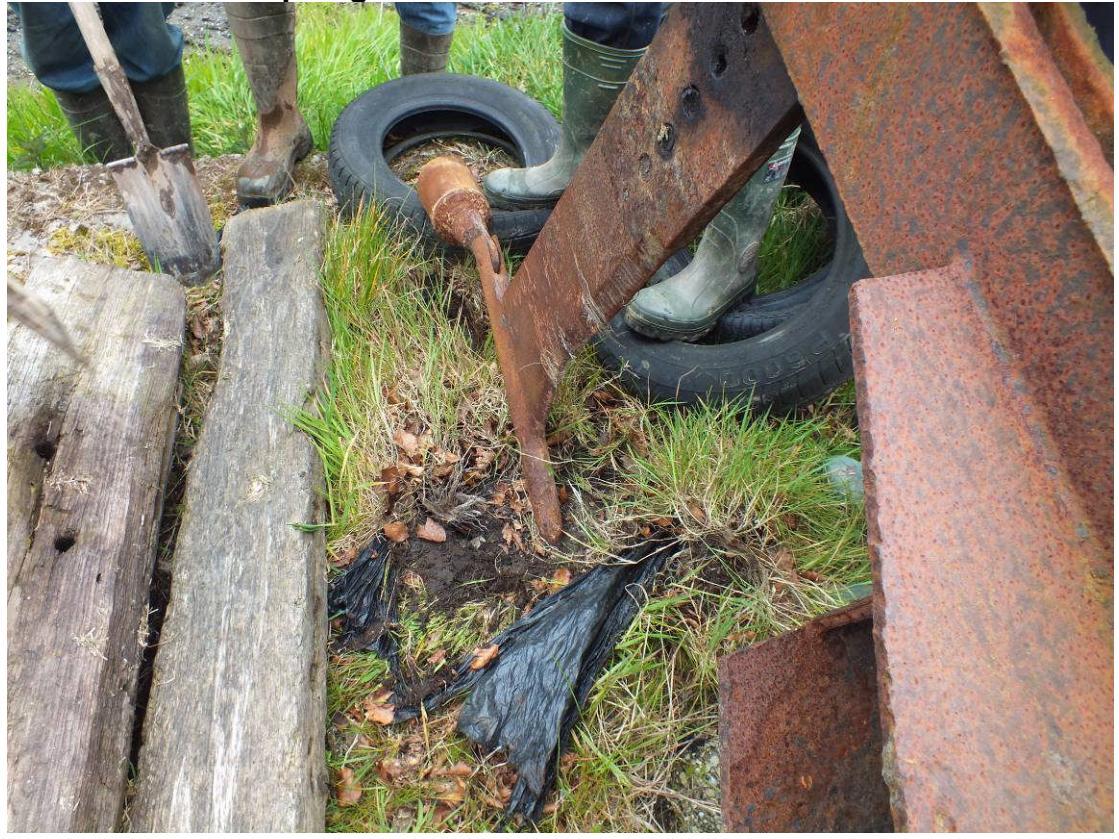
Picture 4 Mole plough used

The mole plough used was found to be inadequate. The basic principles of mole drainage dictate that the trailing expander behind the mole foot be approx 1.1-1.2 times the diameter of the foot. The action of the mole foot creates the channel as well as initiating a network of cracks from the tip of the mole. The role of the expander is to finish and solidify the channel walls by bring about plastic deformation of the walls of the newly opened channel.

Mole drains are formed with a mole plough comprised of a torpedo-like cylindrical foot attached to a narrow leg, followed by a **slightly larger** diameter cylindrical expander. The foot and trailing expander form the mole channel while the leg creates a narrow slot that extends from the soil surface down to the mole channel depth. The success of mole drainage depends on the formation of cracks in the soil that radiate from the tip of the mole plough foot at shallow depths as the soil is displaced forwards, sideways and upwards at an angle of approximately 45° to the horizontal Below a critical depth, dependent on soil mechanical strength and mole plough geometry, the soil flows forwards and sideways, inducing plastic deformation at the foot of the plough. The action of the mole plough creates both a zone of increased hydraulic conductivity adjacent to the mole leg (shallower depths) and a channel for water conveyance and outflow at moling depth, when the soil is sufficiently plastic.

- The expander is in effect forming the channel, which then doesn't undergo any further deformation and is likely to be unstable/poorly formed
- The expander is closing any cracks formed by the foot and causing negligible cracking of its own accord due to short length and poorly defined leading edge
- The draw bar pull increases with the square of the diameter(a 12cm mole needs 9 times the pulling power as a 4cm mole ,144/16=9 times, not 3). This is illustrated by the tracks left in the moled plot, the top sod simply couldn't provide the traction required, even if dry, traction with this mole plough would be an issue. Coupled with this the poorly defined leading edge of the expander and the result is moles being bludgeoned into place. This goes against all the mechanical and hydrological changes that one tries to induce in the soil when moling.

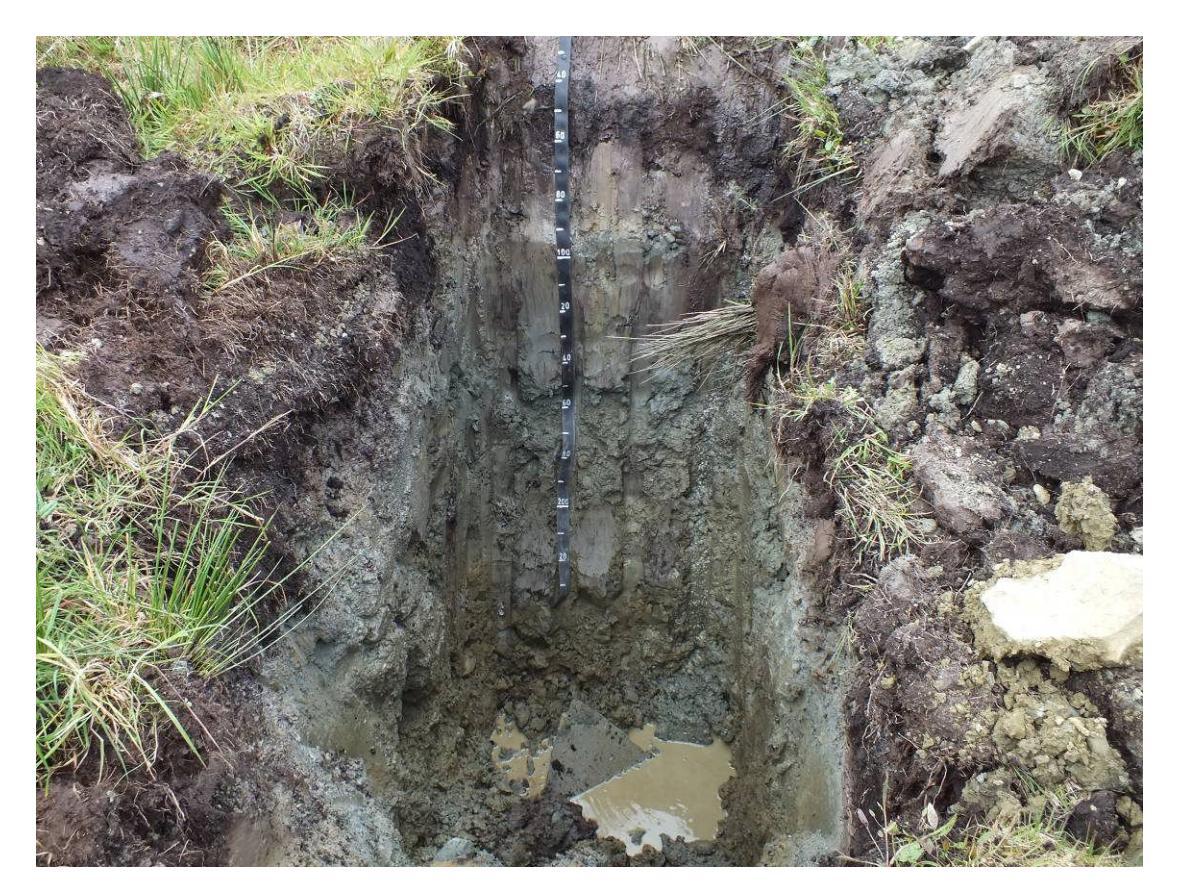
Soil profile of paddock 17

Depth cm	Description
0 - 46	Peat top soil, formerly deep ploughed, poor mineral mix in
	blobs through it. Weak and wet.
46 - 56	Transition loosish organic peat, mineral gley, low density, root
	channels, an iron concentration
56 - 75	Carboniferous clay till, relatively boulder free. Firm.
75 - 150	Less cemented upper carboniferous shale, silty clay loam.
	Wetter than paddock 19 not as compacted
1500- 320	Blue grey, sandy clay, stonier, less cohesive. Possibly limestone influence?

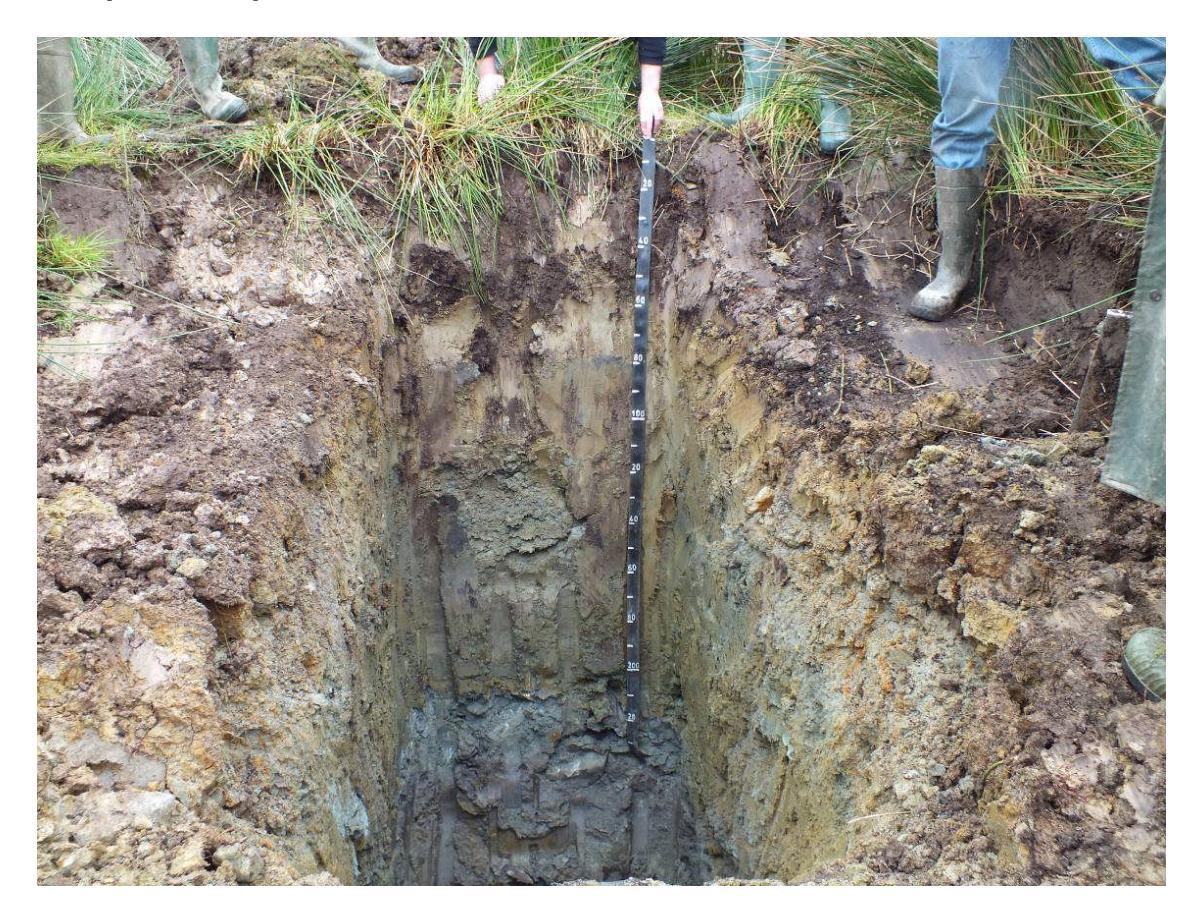
Soil profile of paddock 19

Depth cm	Description
0 - 30	Very organic on top half to organic on bottom. Mineral on bottom
	150 mm. Limed causing peat to be less raw.
30 – 41	Transition loosish organic peat, mineral gley, low density, root
	channels, an iron concentration
41 - 52	Same as above but with less roots and less peaty`. Upper water
	table meeting oxygen. Loosish.
52 - 75	Carboniferous clay till, relatively boulder free. Firm.
75 - 150	Same as above but less cemented
150 - 200	Less cemented upper carboniferous shale, silty clay loam
200 - 290	Blue grey, sandy clay, stonier, less cohesive. Possibly limestone
	influence??
290 - 340	Lens of dark lignite type material. Possibly Emian, most likely a
	buried bog from 8,000 – 9,000 years ago

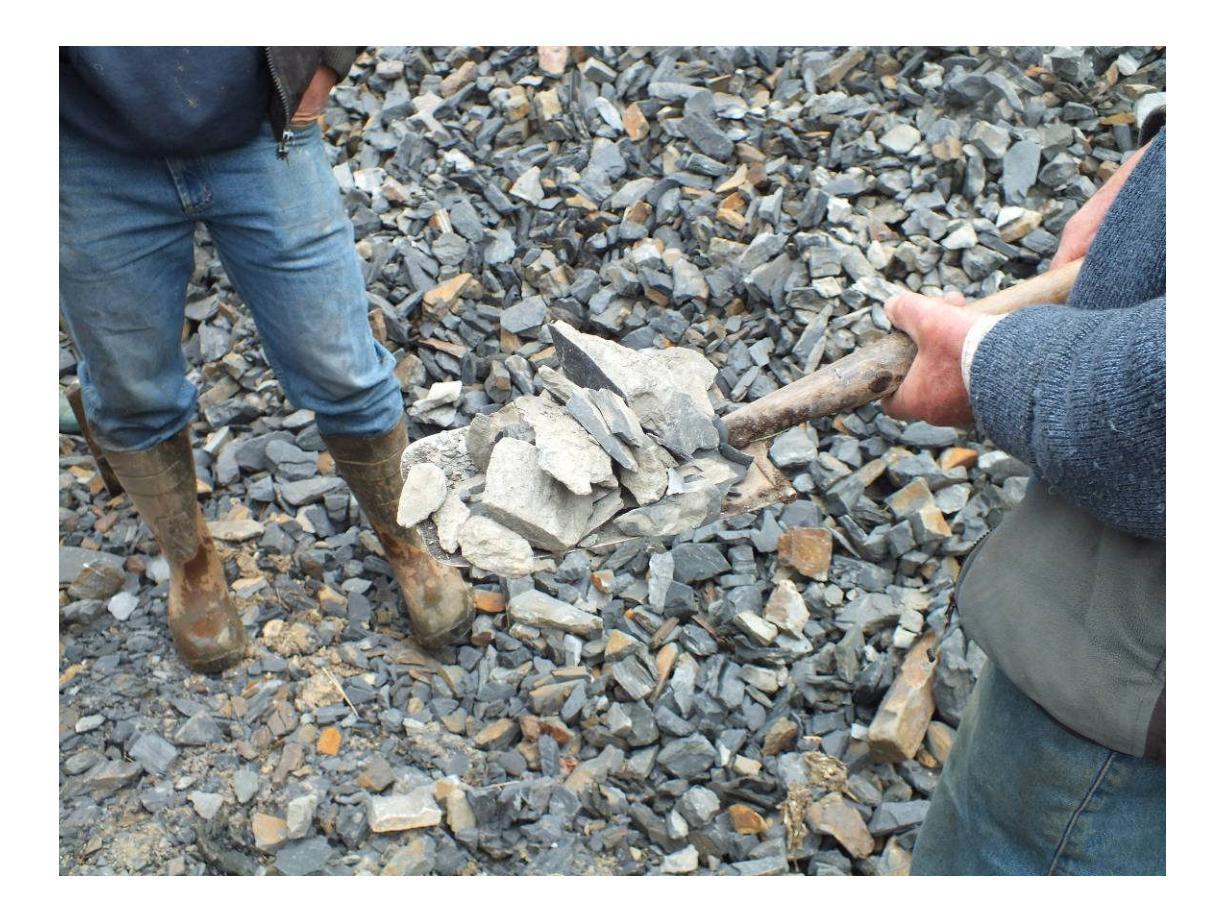
There is pencil gravel available locally (see below) which is screened and relatively cheap which could be suitable for collector drains.

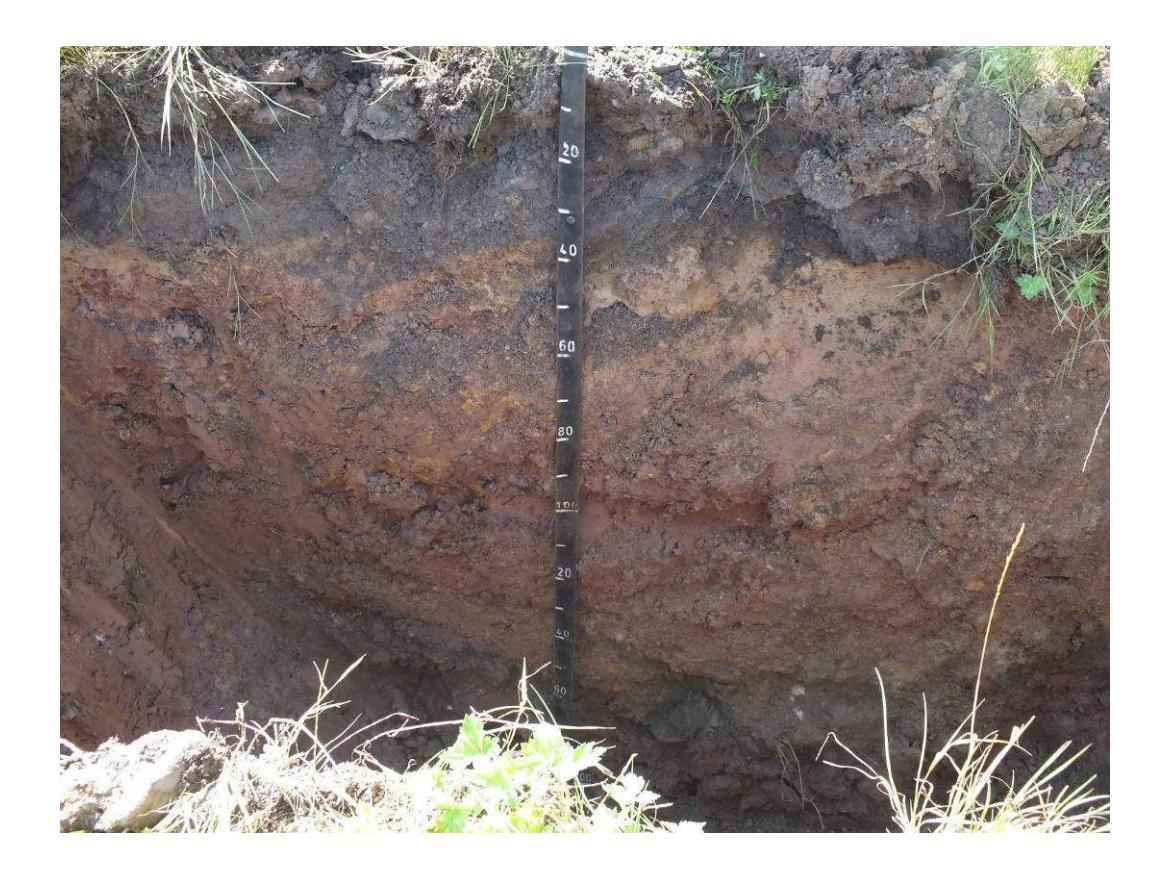
Test Hole 1

Depth cm	Description
0 - 10	Silty clay topsoil, darkish organic material
10 - 20	Light grey, reduced iron layer. Fen mottles, some stone, sandy clay loam
20 - 40	Medium grey, silty clay loam, signs of root cracking, fairly stone free, suggests water sorted
40 - 50	Very light orange, water separated (glacial stream separated) sand, could be glacial outwash.
50 - 130	Typical old red sandstone – till, some rounded stones, signs of rooting to 130, clay skinned surface, natural cracks. Clay loam.
130 - 240	Slightly sandier, sandy clay loam, softer with seepage through this layer with sand lenses, good cracking to 1600

It can be seen from picture above that there was quite an amount of subsidence in the test hole. This continued for the period while we were on the visit.

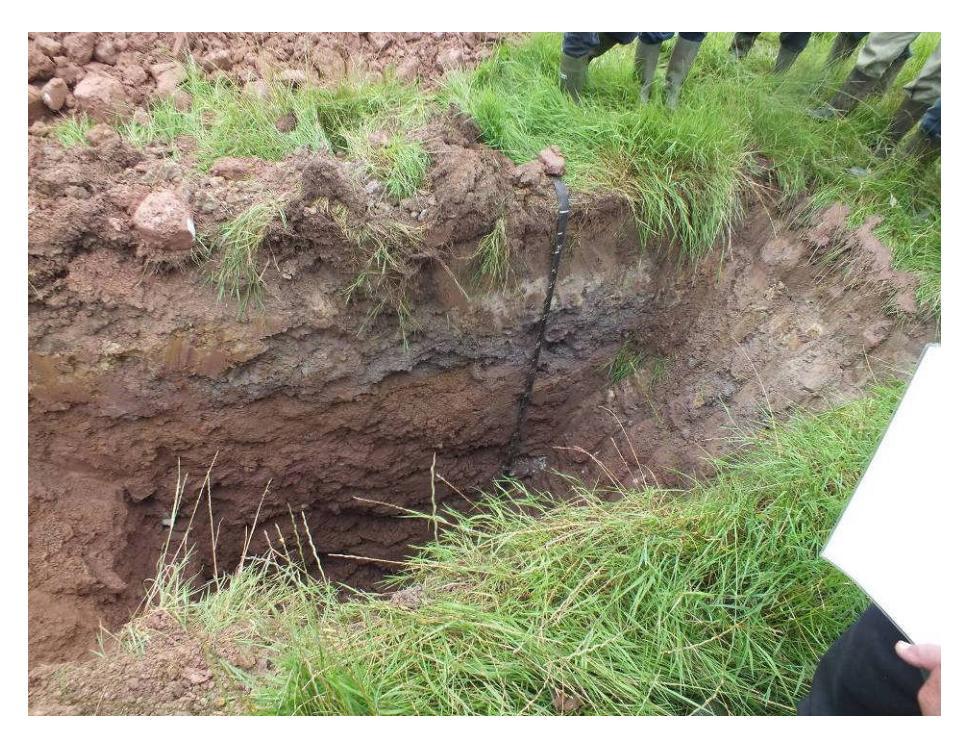
Picture above shows field that was re-seeded last year. Open water courses were cleaned and it was re- fenced.

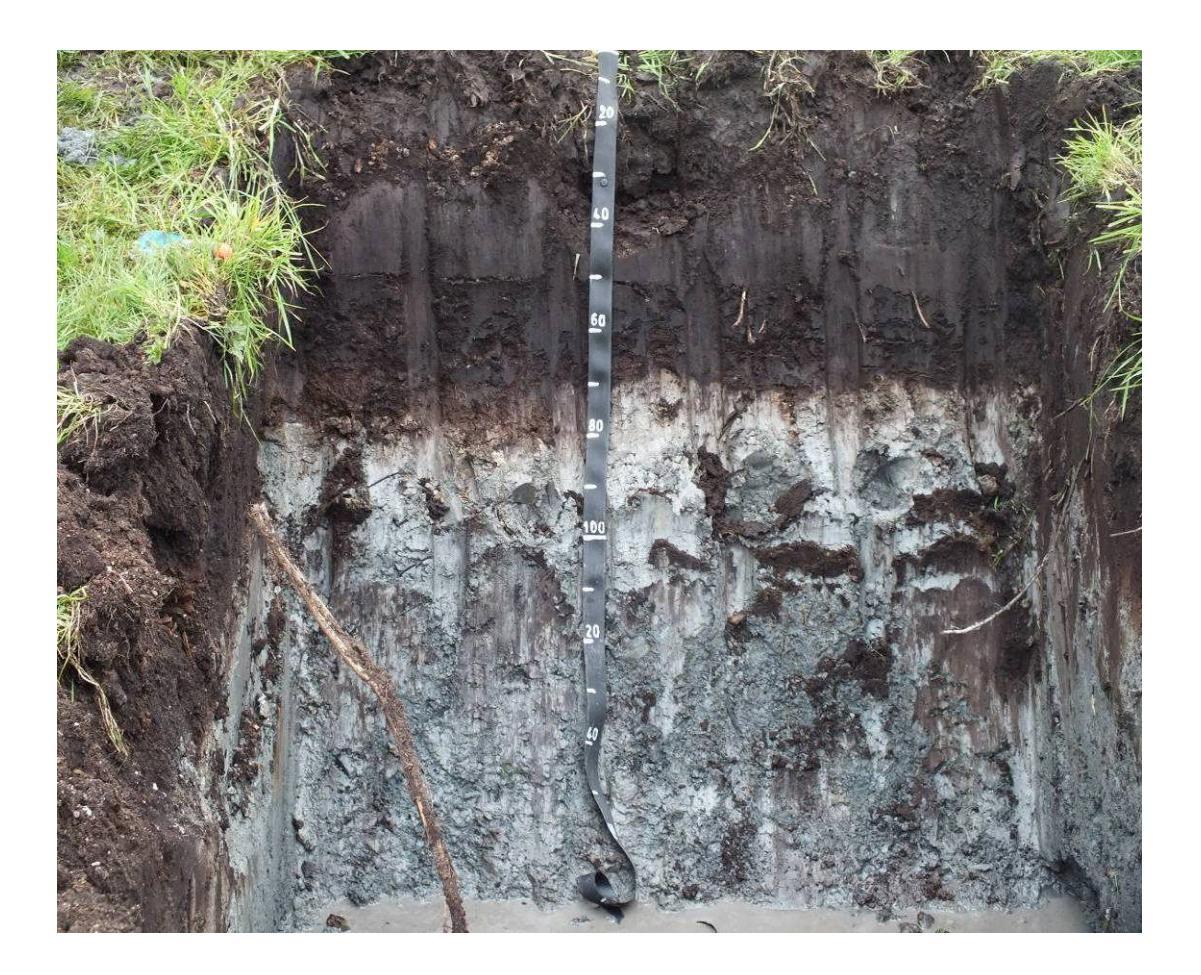
Test hole 1 was opened to a depth of 160 cm the previous afternoon. And left open overnight, water was visible at base of the pit in the morning.

Depth cm	Description
0 - 60	Woody fen peat of blanket peat origin
60 - 90	Weathered gravelly silt with root penetration
90 - 110	Slightly weathered gravelly silt some root penetration. Pit walls
	becoming increasingly unstable.
110- 180	Medium consolidated stony, gravelly silt
180 - 250	Loose (ish) gravelly silt
250 - 320	Bit less permeable more consolidated
320	Gravelly silt. High water ingress noted at base of pit.

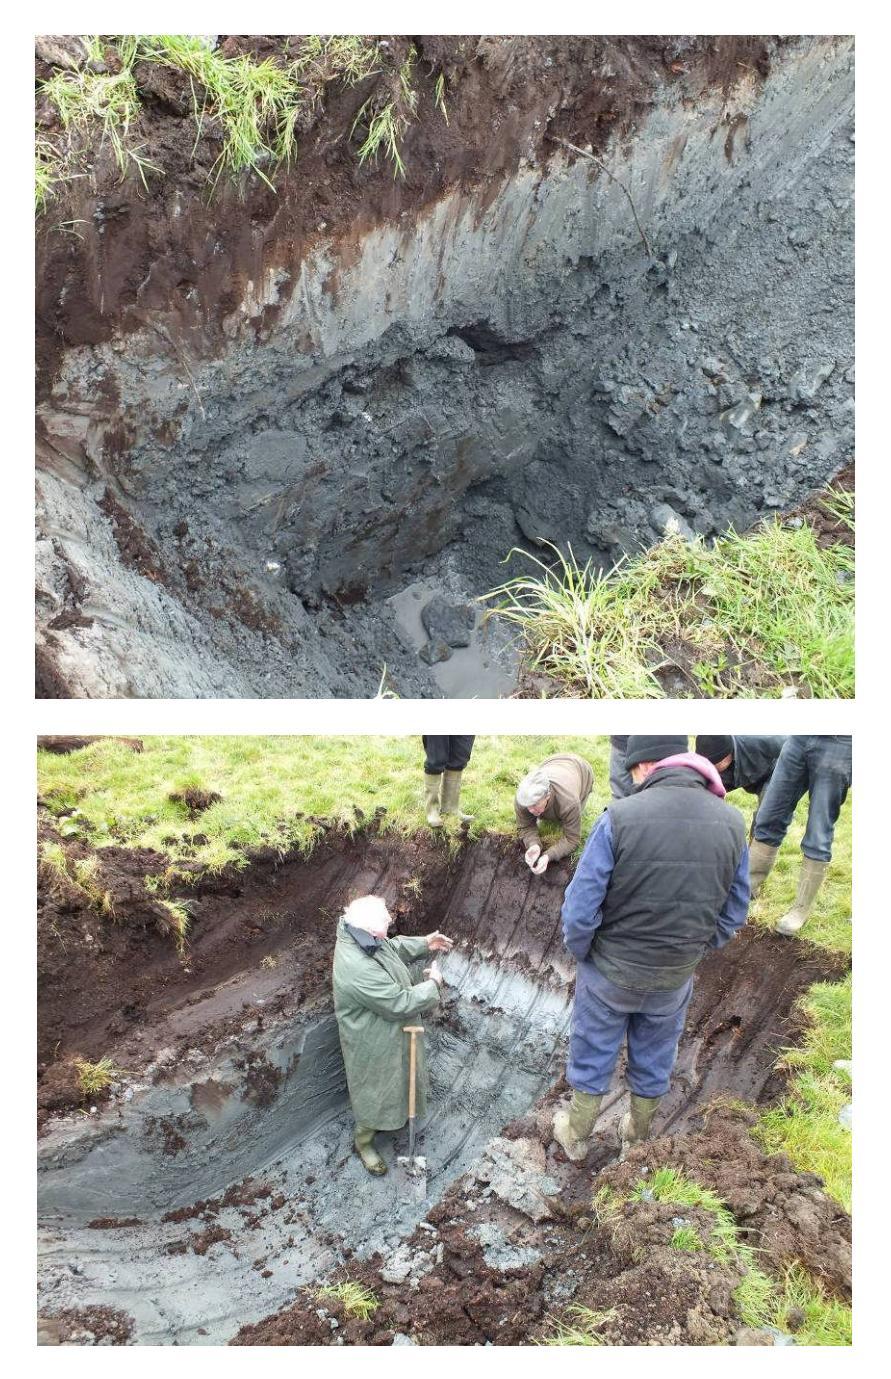
Test hole 2 in paddock 26

Depth cm	Description
0 - 70	Woody fen peat of blanket peat origin
70 - 90	Silt with clay, slight weathering, some root penetration
90 - 110	Silt with little clay, very few stones
110 - 150	First permeable layer. Low rate of seepage noted, sides of pit
	unstable.
150 - 180	Clayey silt with gravel
180 - 260	Less permeable more clay
260 - 300	Lower permeable layer gravelly, clayey silt. Moderate to high
	water ingress noted from base of pit.

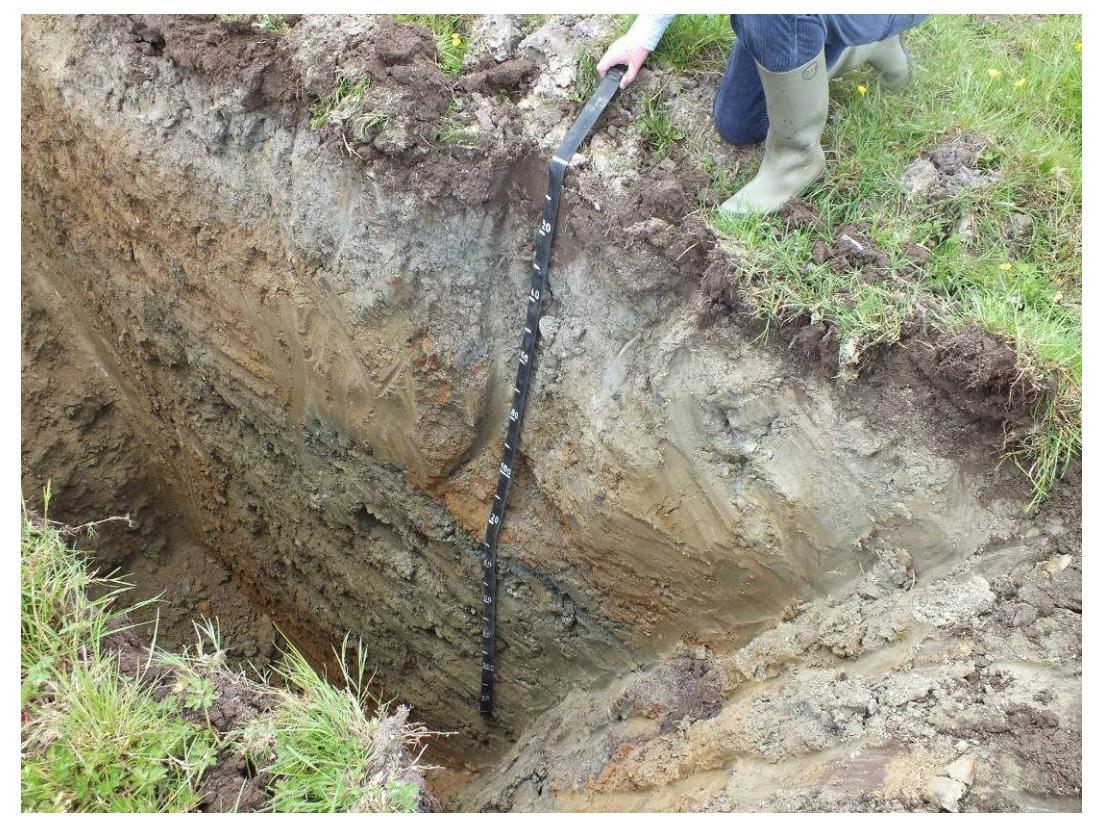
Picture 2: Soil profile Paddock 21

Depth cm	Description
0 - 25	Top soil organic silty clay loam, poor structure (sub-angular)
25 - 65	Silty clay loam, grey layer, no structure
65 - 130	Silty clay loam, highly mottled
130 - 280	Increase in small stone, quite cemented, more gravel, more brittle

Naked moles would be worth a try; however the best option would be gravel mole drains at a depth of 450 - 470 mm. The deluxe version would be deep ripping at 600 mm with gravel moles installed in every second rip.

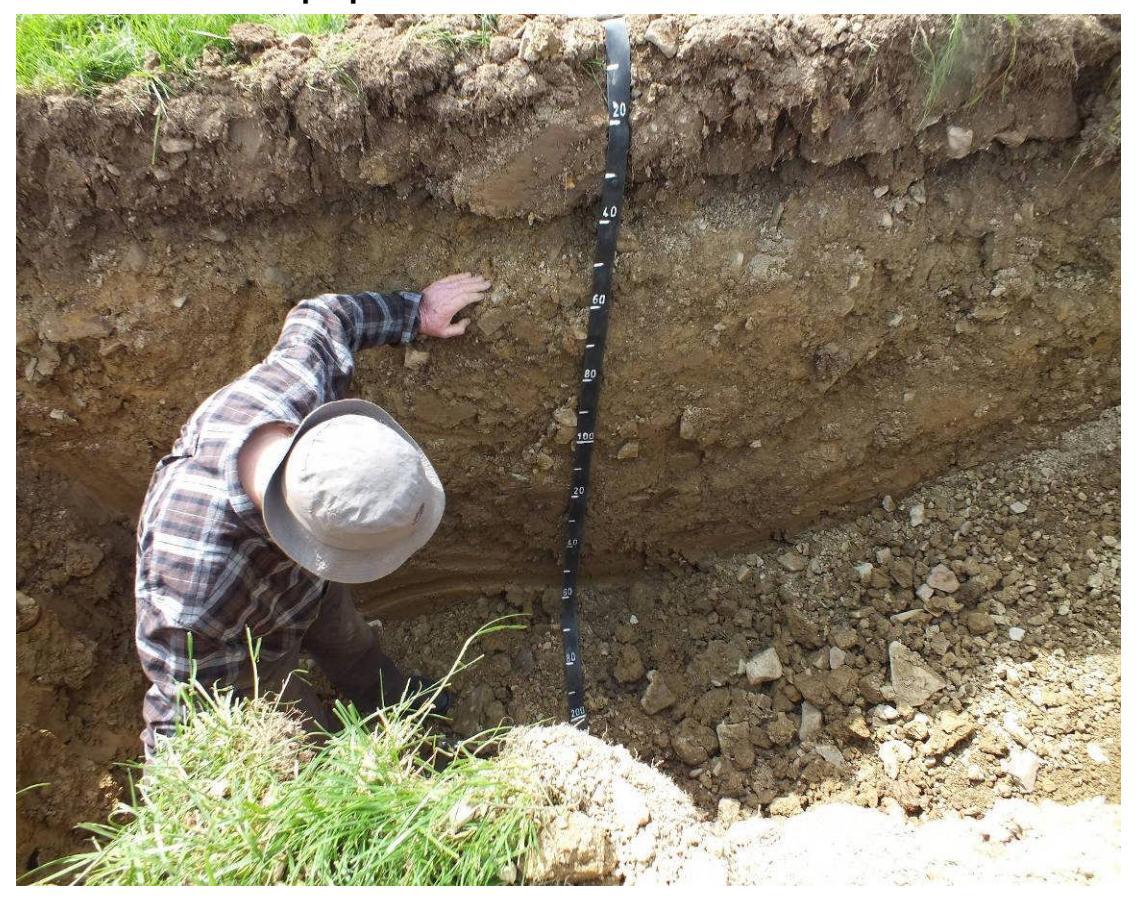
Picture 3: Shallow pit paddock 7

Depth cm	Description
0 - 40	Top soil brown, some rusty mottling. Finer structure, moderate granular
40 - 90	Silty loam to clay loam,
90 - 165	Silty clay loam, cemented, more small stone

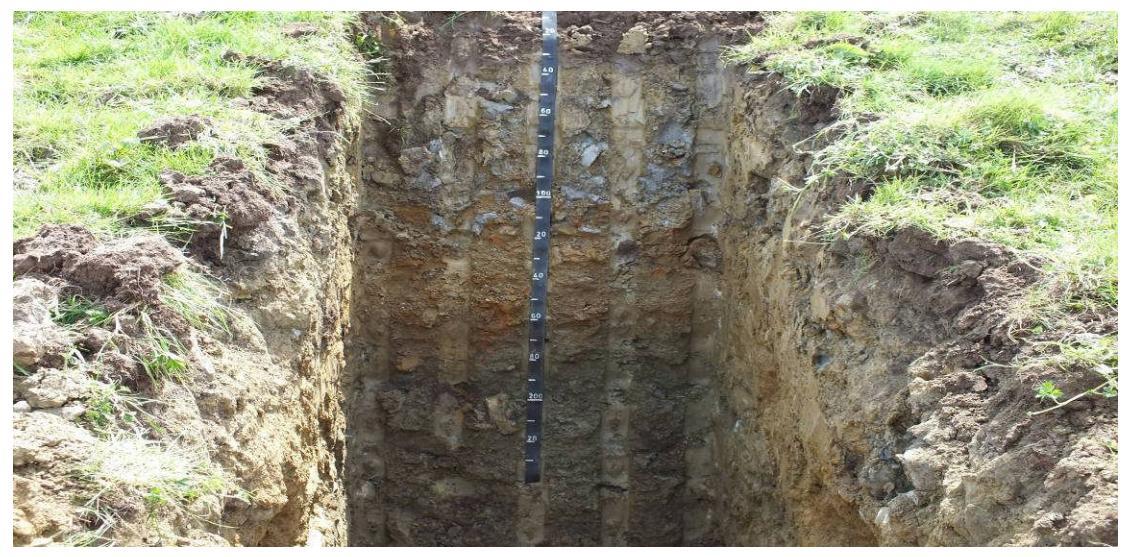
Picture 3: Deep pit paddock 7

Depth cm	Description
	Top soil dark brown, coarse blocky weak structure
0 - 30	
30- 90	Stones 10 – 20 cm through it. Weak blocky structure, white to cream in colour
90 – 160	Silty clay loam, highly mottled, fair stone content, compact
160 – 360	Increase in small stone, quite cemented, more gravel, more brittle

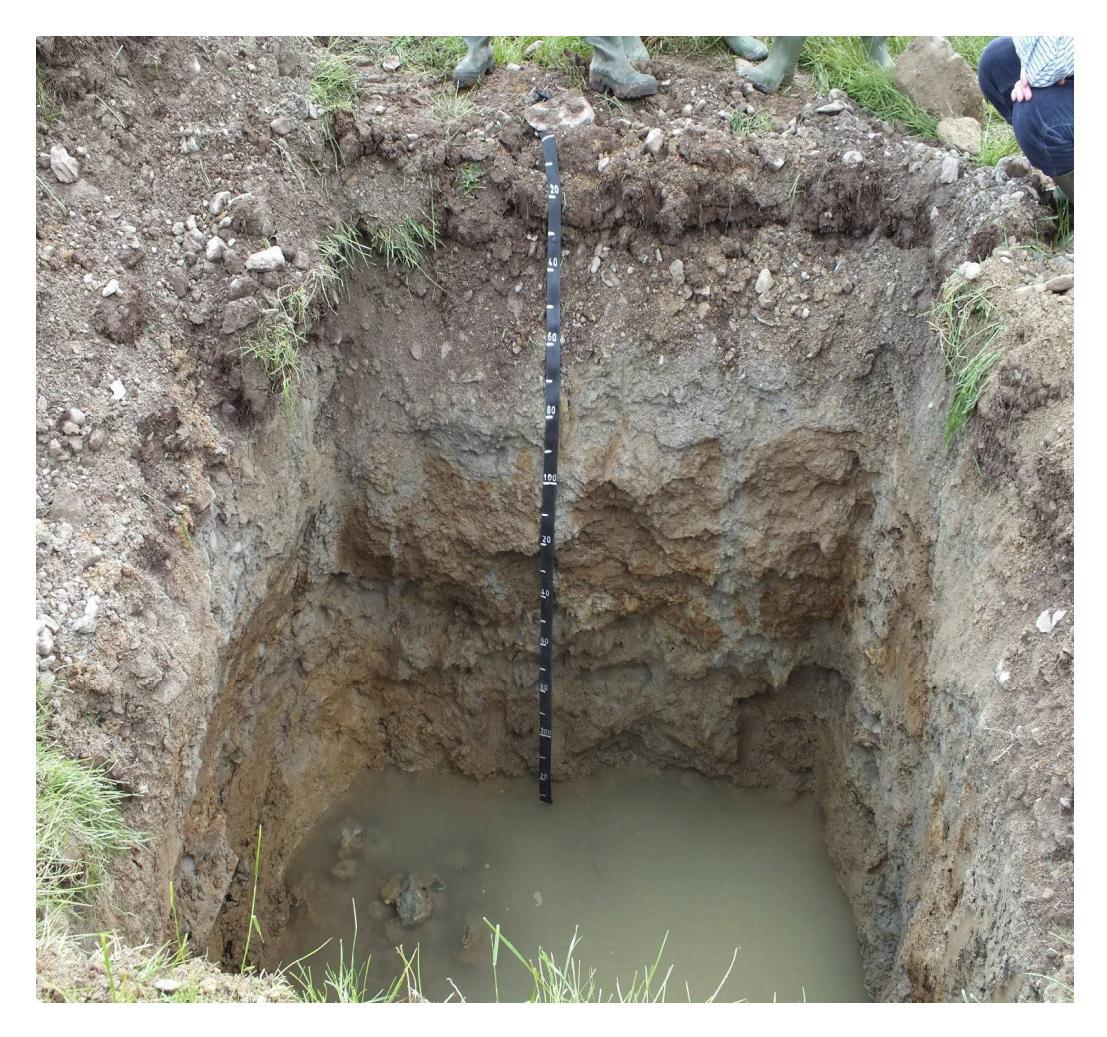
Test Hole 1 in Paddock 12

Depth cm	Description
0 - 20	Dark brown, organic, silty clay loam
20 - 35	Gravelly, stony layer
35 - 70	Fairly tight gley, very gritty silty clay loam
70 - 140	Iron depositions with some manganese concretions increasing at 1200 - 1300
140 - 280	Stony, gritty, gravelly silty clay loam going on to silty clay with lots of cobble type material. Seepage visible at 1500. Getting quite bouldery at 2700
280	Bedrock

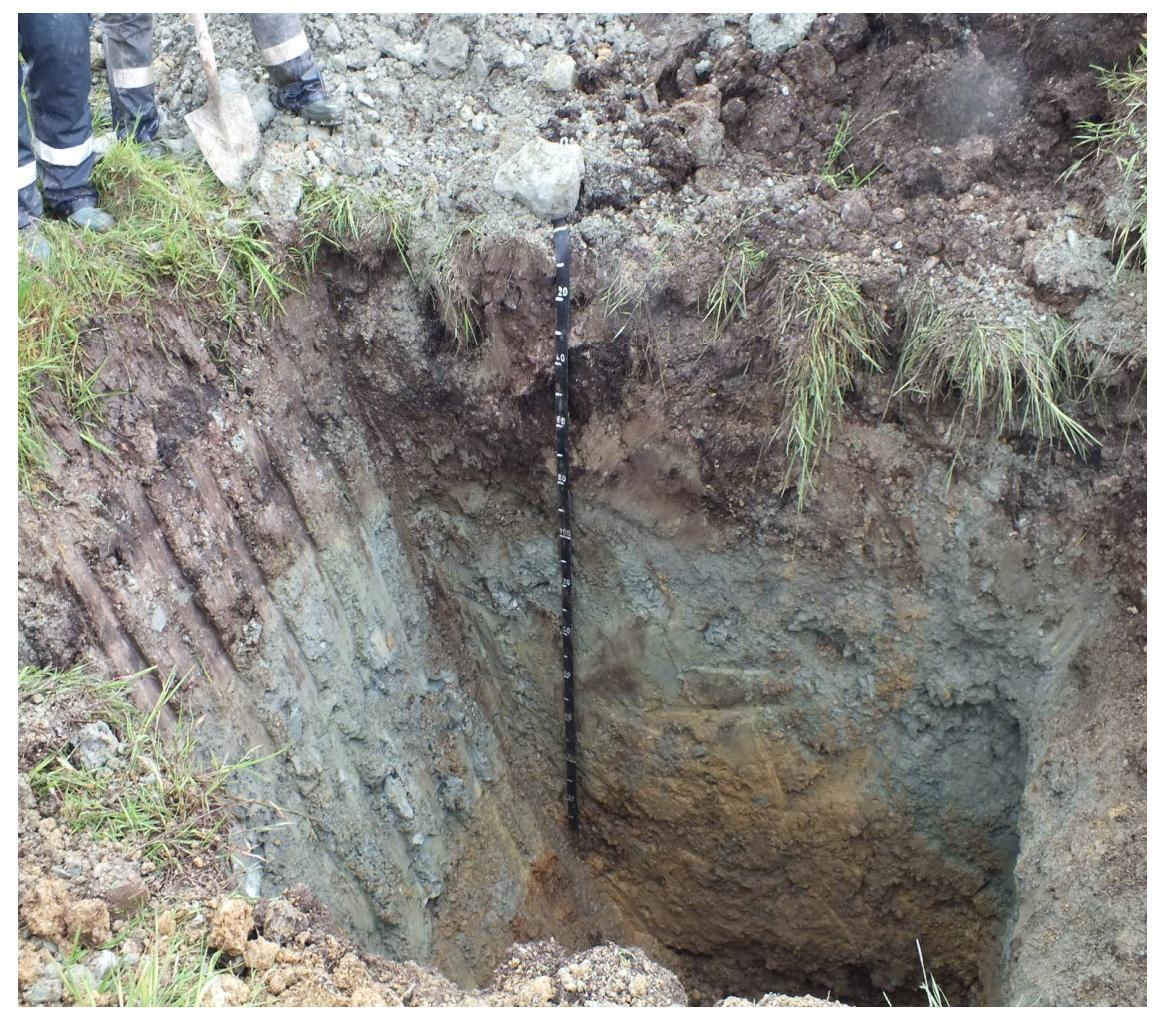
Test Hole 2 Peat turned site in Paddock 19

Depth cm	Description
0 - 50	Original peat very soft dark organic material, mixed with mineral material
70 - 80	Gley, silty clay loam, quite gritty
80 - 150	Low porosity, fairly dense, very gritty and silty.
150- 290	Stony, gritty, gravelly silty clay loam going on to silty clay with lots of cobble type material. More boulders than Test Hole 1.
