Teagasc Heavy Soils Dairy Programme Review

Complied by

Objectives of Heavy Soils Programme

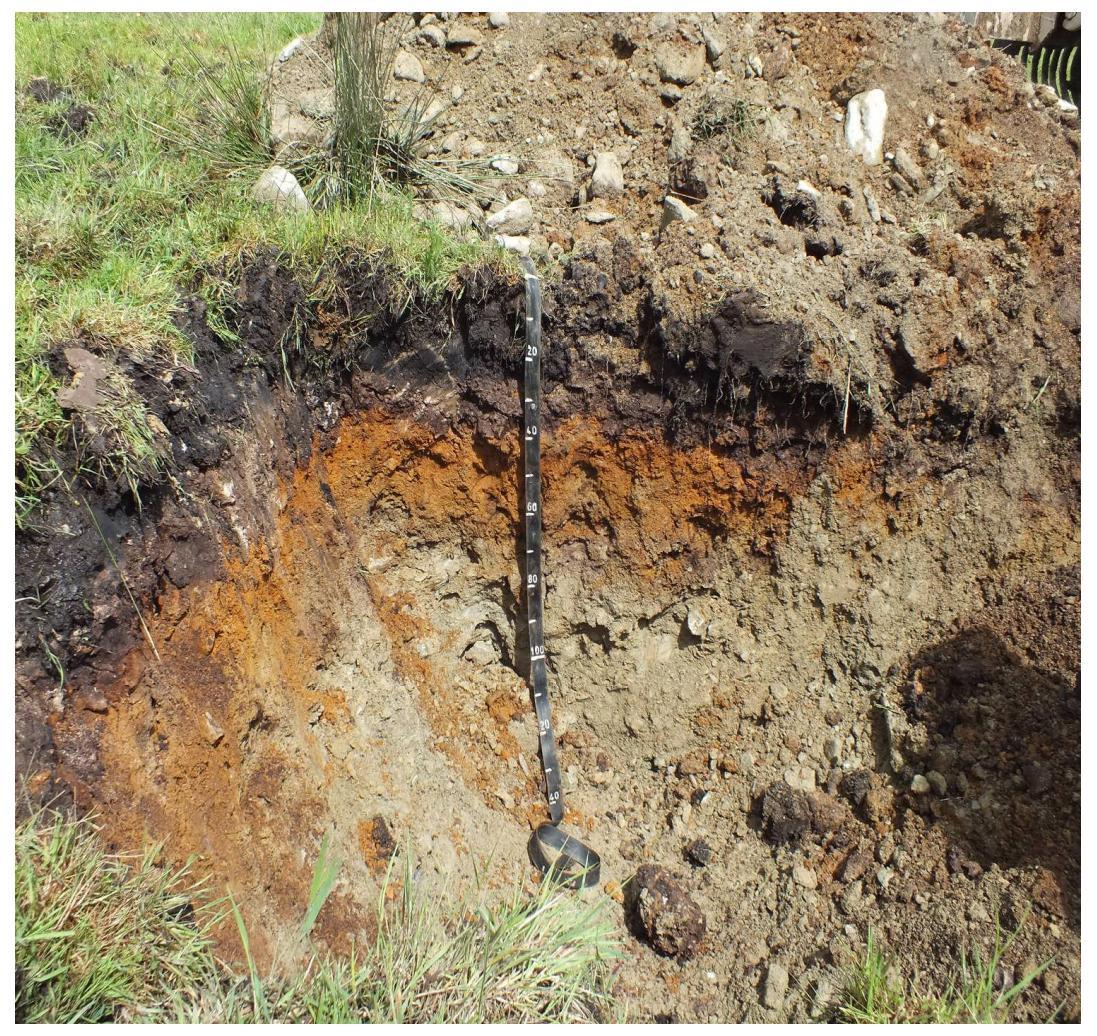
Test Hole 3 in Paddock 19

Depth mm	Description
0 - 300	Peat reforming again after being turned in the past (probably
	done with a ripper).
300 - 600	Very brown loosened podzol reforming with a reforming iron
	pan at 300mm
600 - 1500	Meeting rock at 1500mm which is probably fissured as the soil
	over it is dry.

Ripping was carried out approximately 10 years ago; this operation would have shattered the iron pan and allowed movement of water through the profile. The area is now reverting to its wet state with a lot of surface water/poaching. The test hole shows signs of reformation of an iron pan, and resulting reformation of peat. The formation of an iron pan is encouraged where acid soil conditions prevail, thus the addition of lime may slow or stop altogether the reformation of a pan if ripped again?

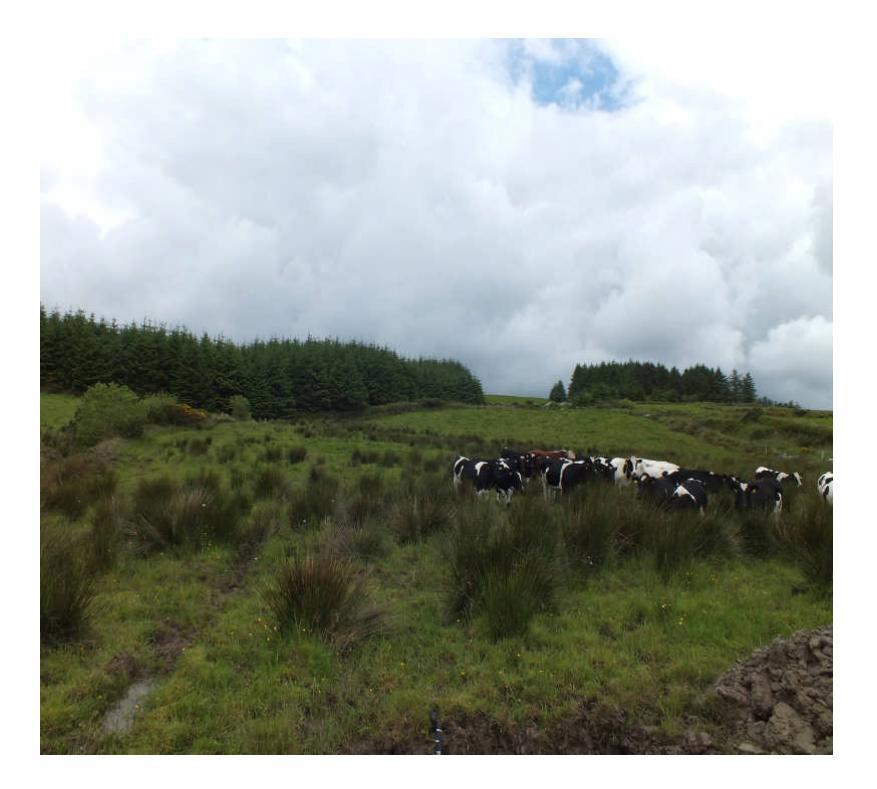
Picture 2 (above) shows field where test hole 3 was dug (paddock 19). The green field in the background is the highest point of the farm at 300 meters.

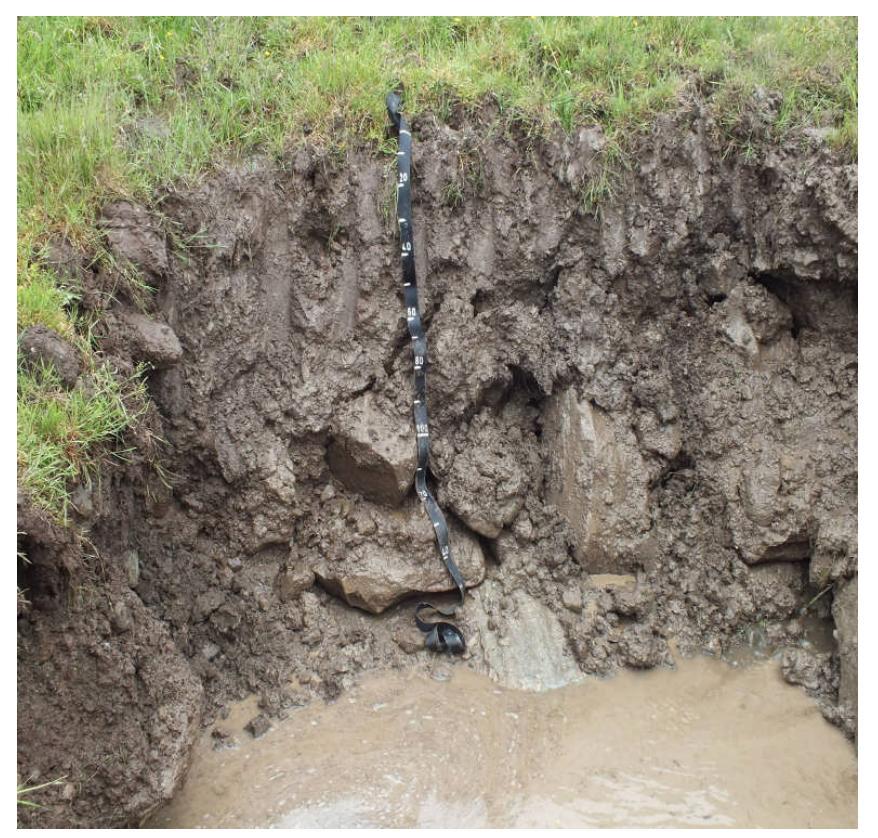
Picture 3 which was taken in Paddock 19 is an example of the type of drains that were installed on the farm. The large stones that can be seen around the tape were used to fill the drain. There was a very good flow of water in this drain.

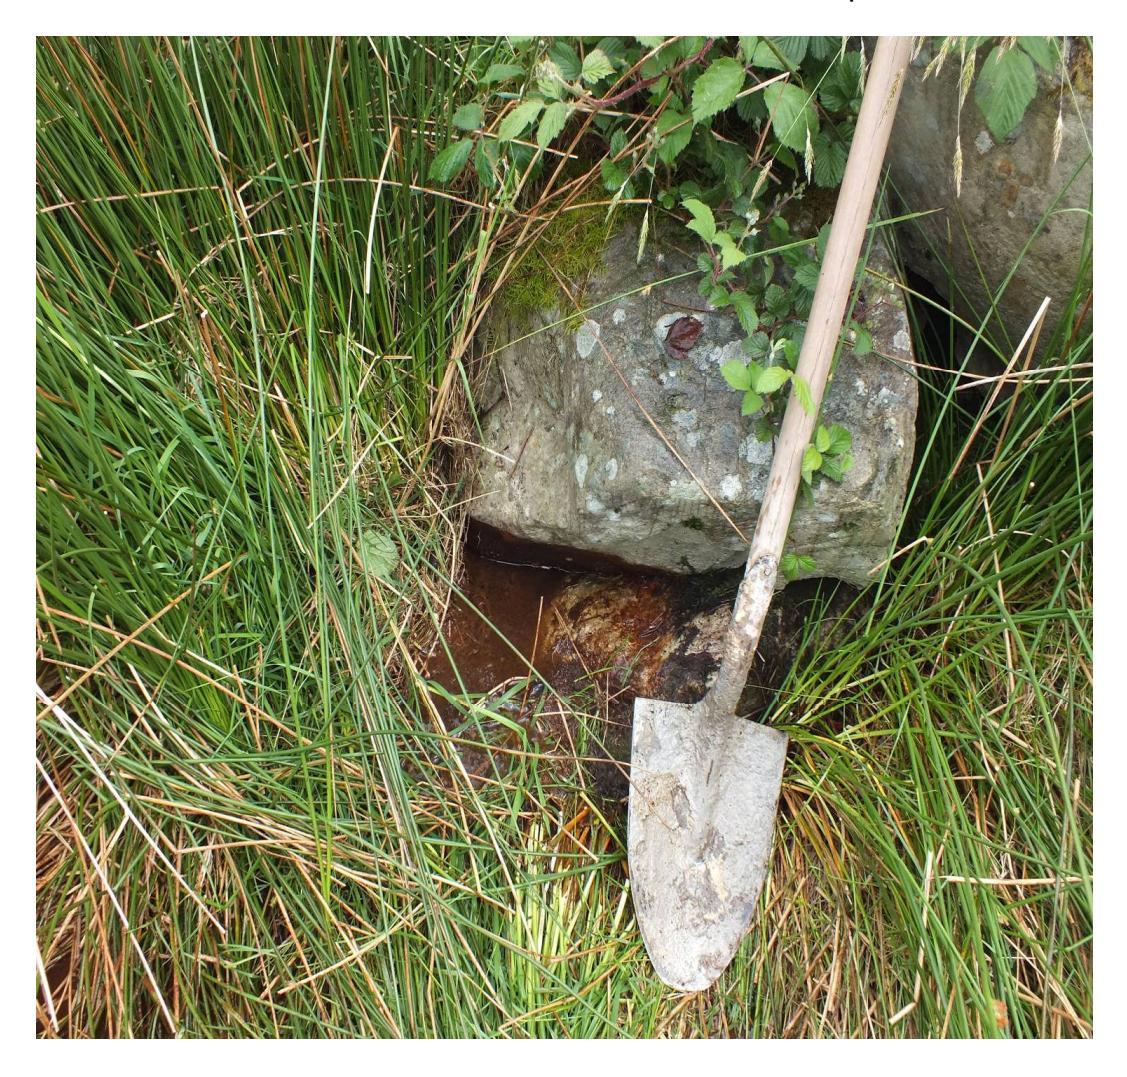
Picture 4 below shows the outlet from this drain into an open water course.

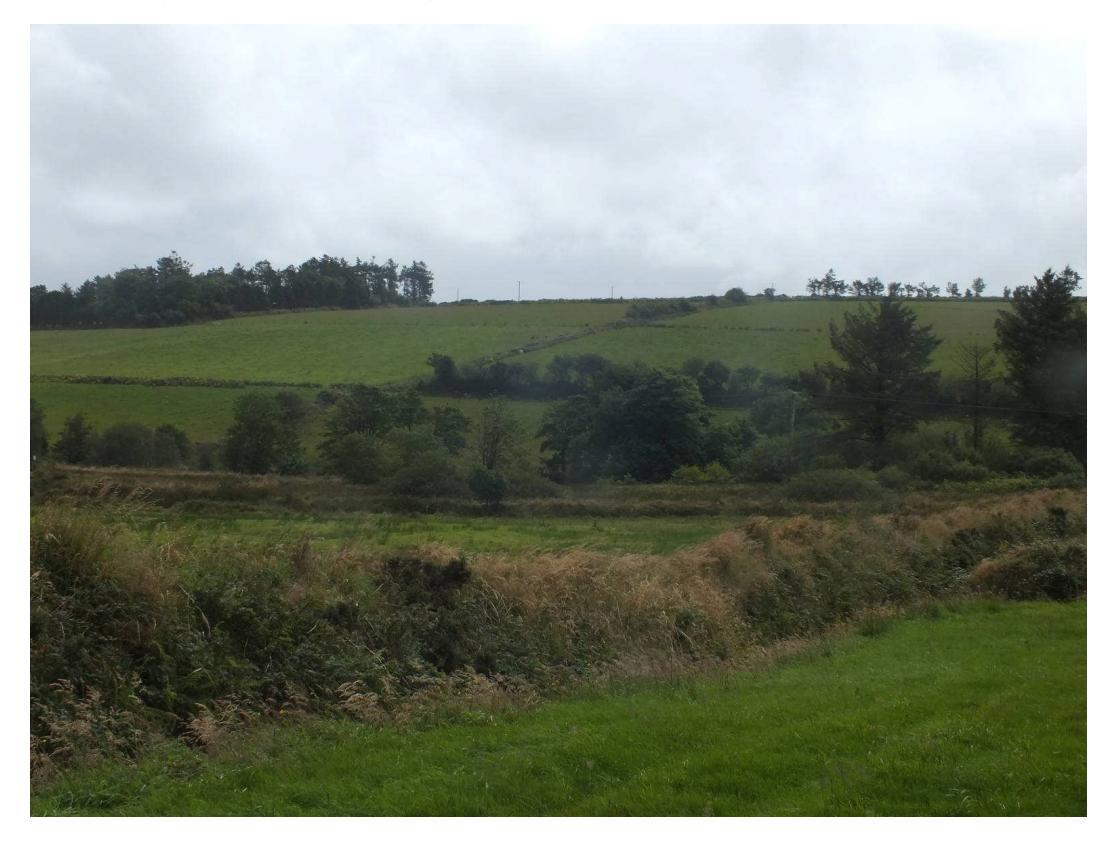
Farm visit took place on Wednesday 15th August 2012. Picture below shows an overview of some of Sean's farm. Test holes 1 and 2 were dug on top of the hill behind row of trees at top right of picture. Test hole 3 was dug 50 meters right of the bottom right hand side of picture.

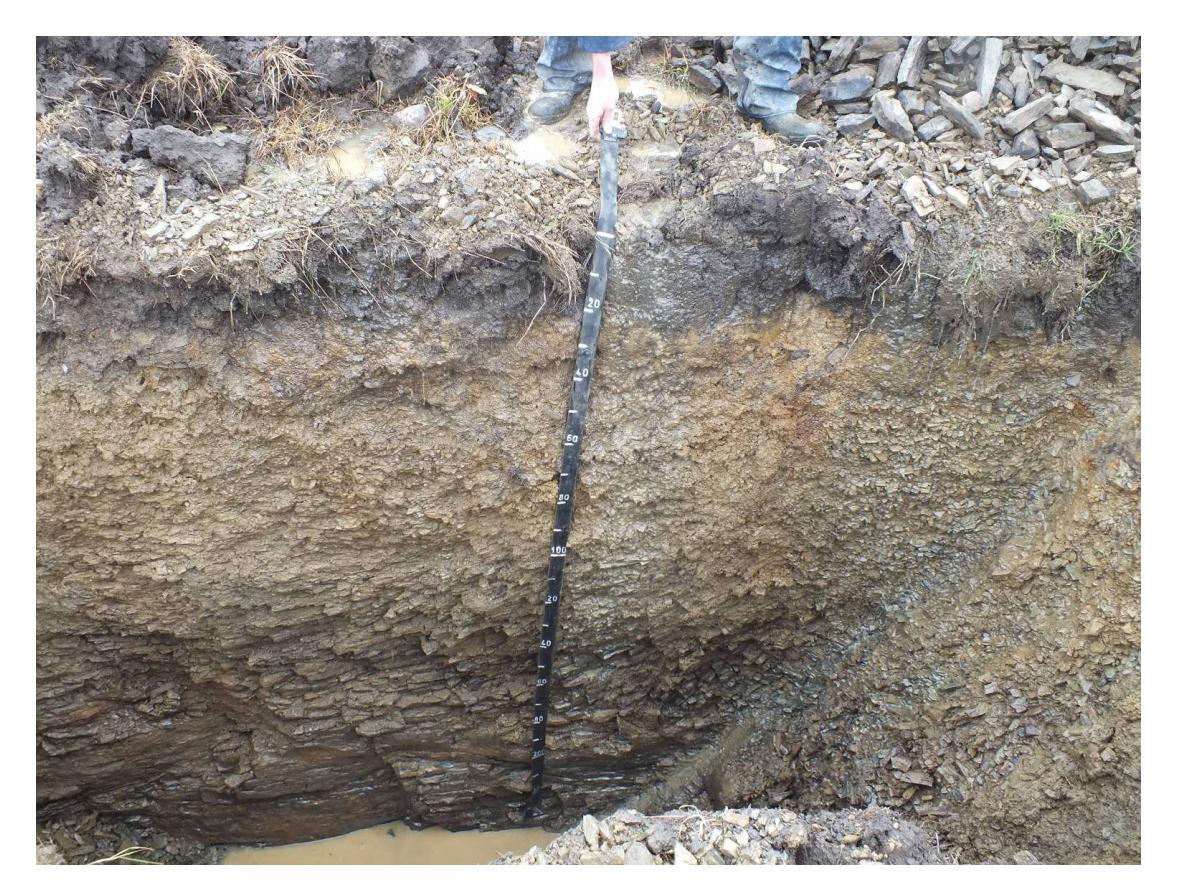
Depth cm	Description
0 - 30	Peaty top soil
30 - 45	Yellowish layer, gritty clay/silty loam
45 - 155	Clay loam, increasing concentration of stones, high pebble content
155 - 200	Permeable shattered shale with large ingress of water
200 - 250	Less permeable shale, less shattered, close to bed rock

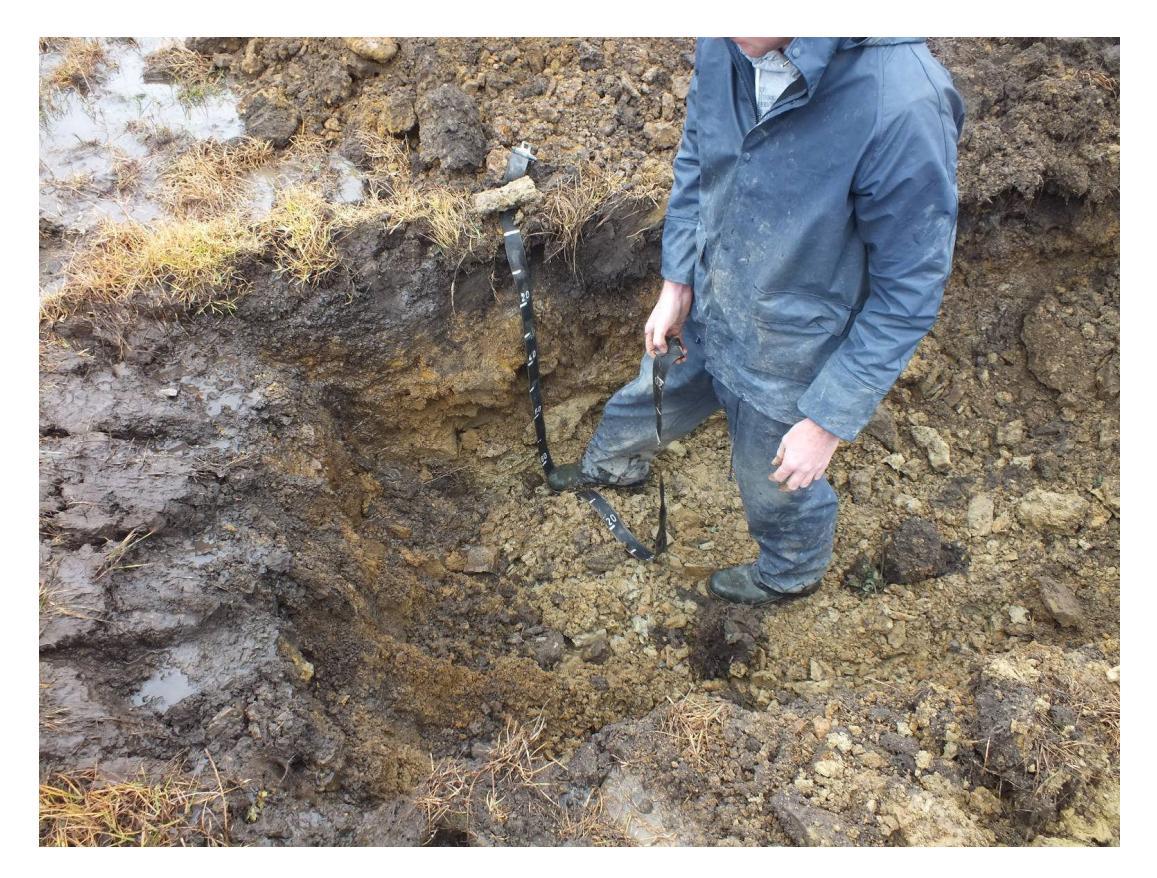
Depth cm	Description
0 - 25	Peaty top soil
25 - 50	Silty clay loam
50 - 80	Clay loam, increasing concentration of stones, high pebble content
80	Bedrock

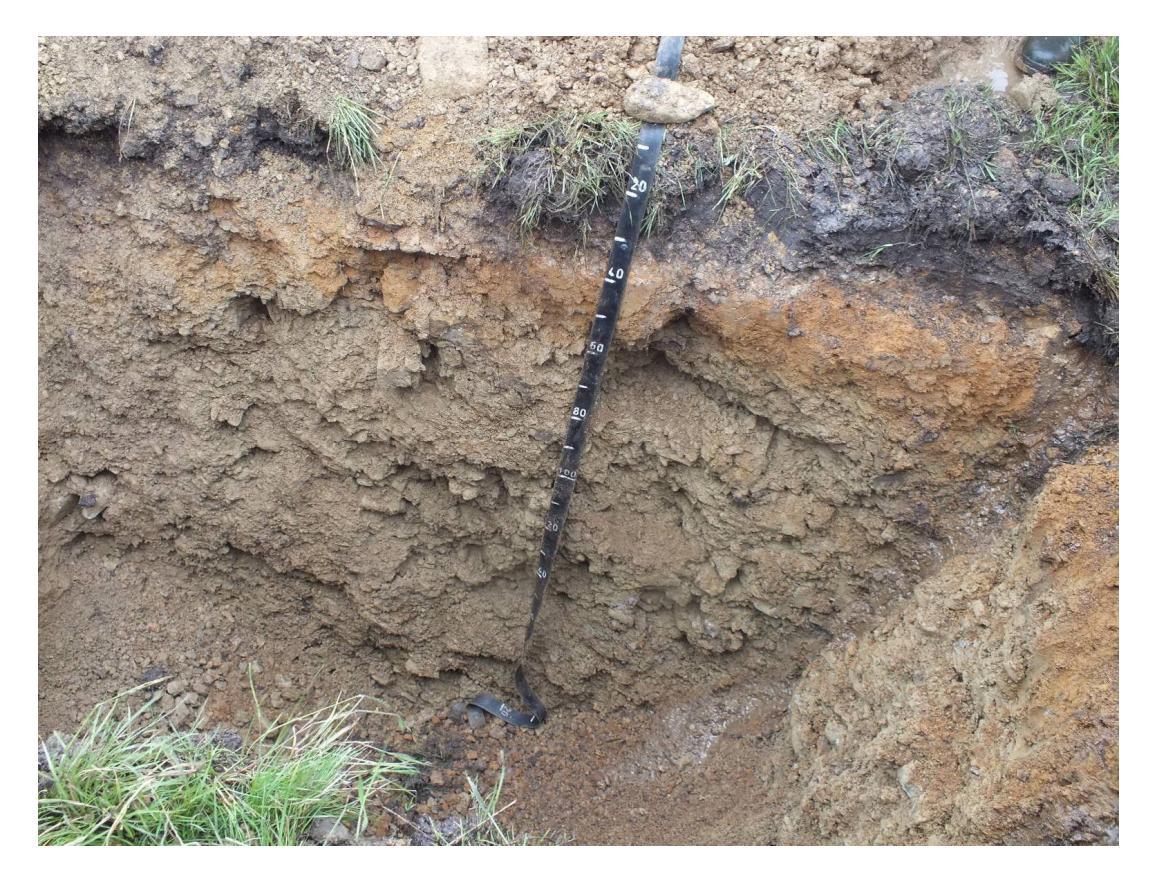
Depth cm	Description
0 - 25	Top soil highly organic (peaty)
25 - 30	Compact leeched layer
30 - 60	Yellowish red silty loam of the podzol type. Where red not
	present grey in colour, reasonably compact
60 - 350	Little looser, stony, reasonably compact, water table visible at
	approx 3400 after 35 minutes

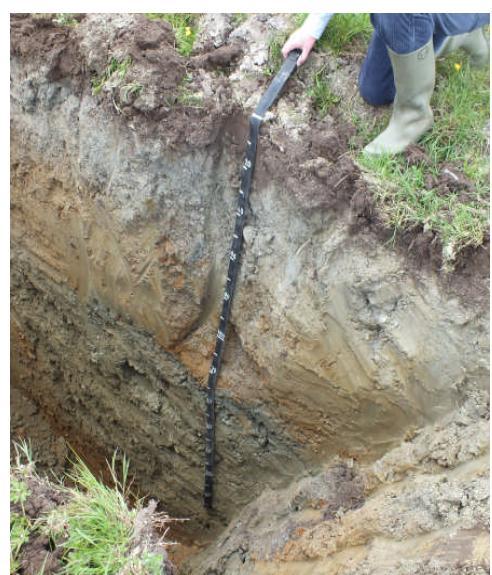
Fig. 1a .Test pit excavation

Knowledge of previous drainage schemes in the area, and their effectiveness will often provide an insight into the causes. A number of test pits (at least 2.5 m deep) should be excavated within the area to be drained. The test pits should be dug in areas that are representative of area as a whole. As the test pits are dug, the faces of the pits are observed, soil type should be established and the rate and depth of water seepage into the test pit (if any) recorded. Visible cracking, areas of looser soil and rooting depth should be noted as these can convey important information regarding the drainage status of the different layers. The depth and type of the drain to be installed will depend on the interpretation of the characteristics revealed by the test pits.

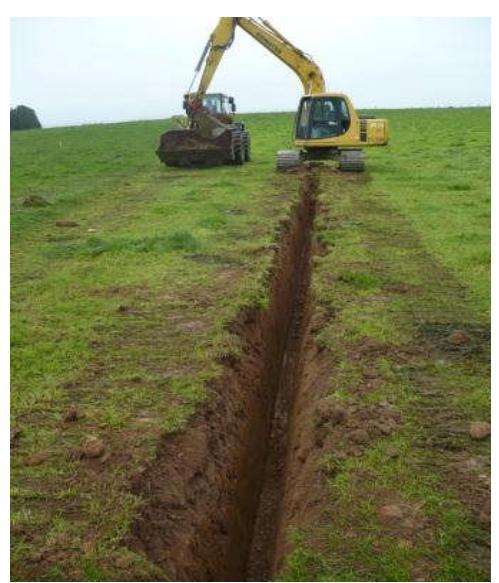
Fig 1b. Drainage trench excavation

Clean aggregate should to be used to surround the land-drain pipe in conventional and deep drains. The gravel should be filled to a minimum depth of 300 mm from the bottom of the drain to cover the pipe. The stone should provide maximum connectivity to a layer of high *hydraulic conductivity*. The purpose of a drain pipe is to facilitate a path of least resistance for water flow. In long drain lengths (greater than 30m) a drain pipe is vital to allow a high a flow-rate as possible from the drain, stone backfill alone is unlikely to have sufficient flow capacity to cater for the water volume collected. Only short drain lengths (less than 30 m, or the upstream 30m of any drain) are capable of operating at full efficiency without a pipe.

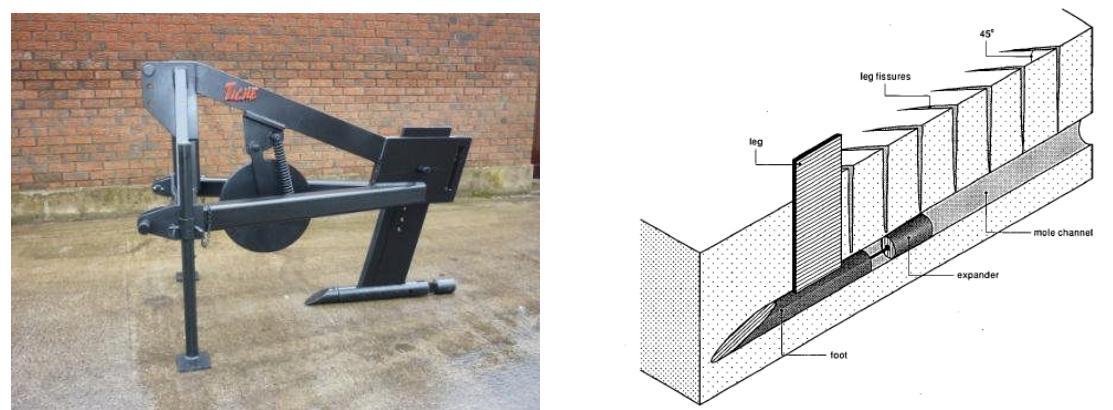
Fig. 2a .Mole plough showing cylindrical foot and expander, 2b. Cracking and channel formation

Mole drainage is suited to soils with a high clay content which form stable channels. Mole drains are formed with a mole plough comprised of a torpedolike cylindrical foot attached to a narrow leg, followed by a slightly larger diameter cylindrical expander. The foot and trailing expander form the mole channel while the leg creates a narrow slot that extends from the soil surface down to the mole channel depth. The success of mole drainage depends on the formation of cracks in the soil that radiate from the tip of the mole plough at shallow depths as the soil is displaced forwards, sideways and upwards. Below a *critical depth*, dependent on soil mechanical strength and mole plough geometry, the soil flows forwards and sideways, bringing about compaction at the foot of the plough. Thus the action of the mole plough creates both a zone of increased hydraulic conductivity adjacent to the mole leg (shallower depths) and a channel for water conveyance and outflow at moling depth.

The effectiveness of mole drains depends on the extent of suitable cracking during installation. As such the ideal time for carrying out mole drainage is during dry summer conditions, this will cause maximum cracking in the upper soil layers as well as facilitating adequate traction preventing wheel-spin on the surface.

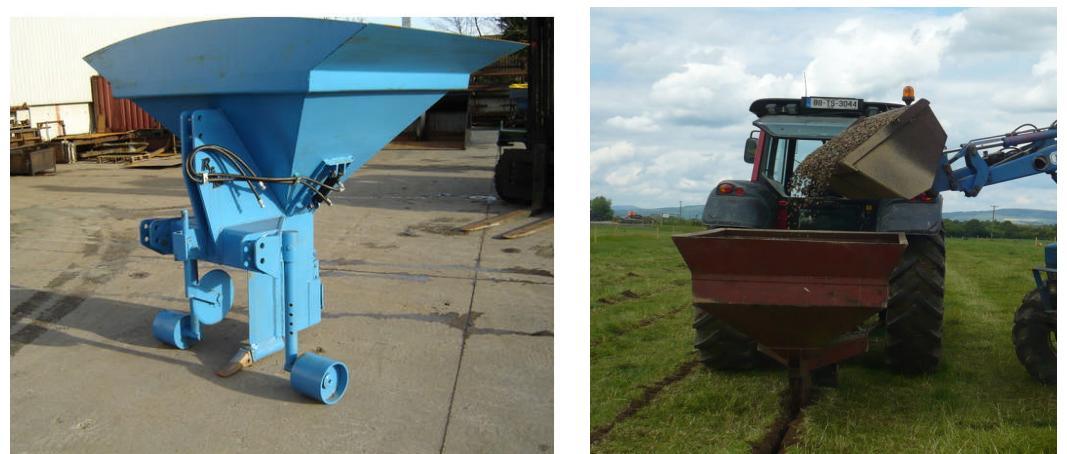
Fig. 3a. Gravel Mole plough showing hopper, 3b. Operation and filling of gravel mole plough

Where a test pit shows little ingress of water at any depth a shallow drainage system is required. These soils that have no obvious permeable layer and very low hydraulic conductivity are more difficult to drain. Shallow drainage systems are those that aim to improve the capacity of the soil to transmit water, these include mole drainage and gravel mole drainage. The aim of these drainage techniques is to improve hydraulic conductivity by fracturing and cracking the soil and to form a network of closely spaced channels.

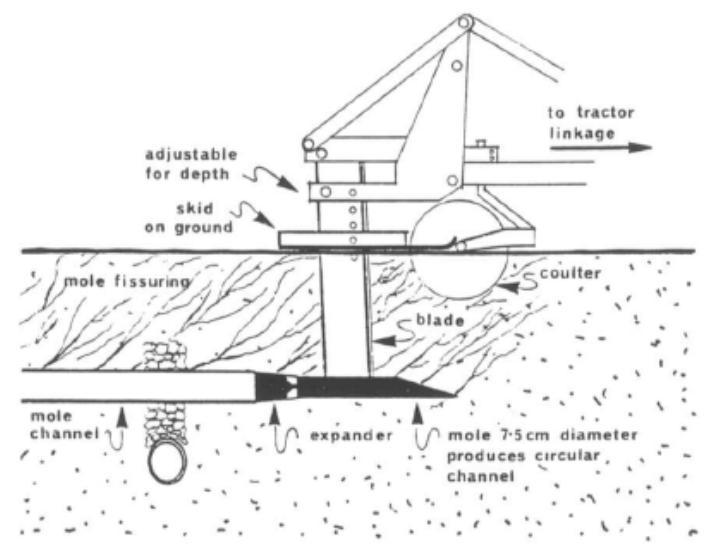
Fig. 4. Mole ploughing showing intersection with a piped collector drain

Collector drains, which are installed across the slope at 0.75 m BGL, are required for all mole drains. Depending on the topography and slope the collector drains will be at a spacing of 10–60 m. A larger spacing reduces costs but results in a higher chance of failure. The mole drains themselves are drawn at right angles to the collectors (up-slope) at spacings of 1.0-1.5 m and a depth of approximately 0.4-0.5 m. Stone backfill for collectors should be filled to within 250 mm of the surface to ensure interconnection with the mole channels.
